213vA040A

**Re: 888 Beach - 888 Beach Avenue, 1500 Hornby Street, and 1501 Howe Street, Vancouver
Final 2013 Depreciation Report**

2013 DEPRECIATION REPORT FOR

888 Beach

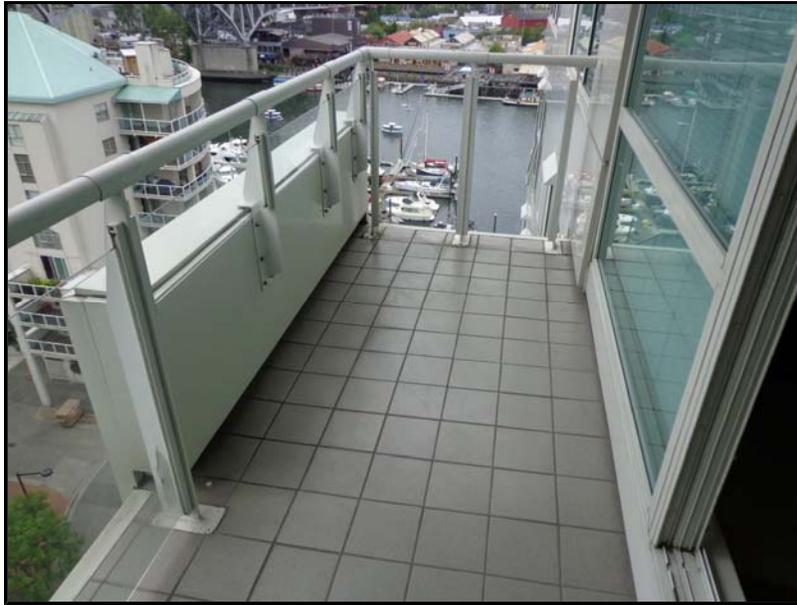
Photo No. 11: Balcony (Original tile at Ocean Tower. Others have elastomeric finish.)

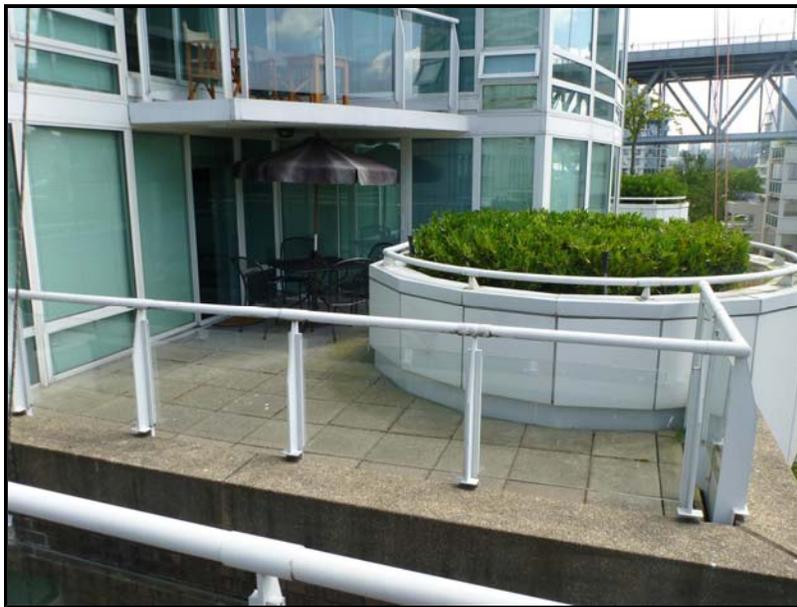
Photo No. 12: Rooftop terrace (typical)

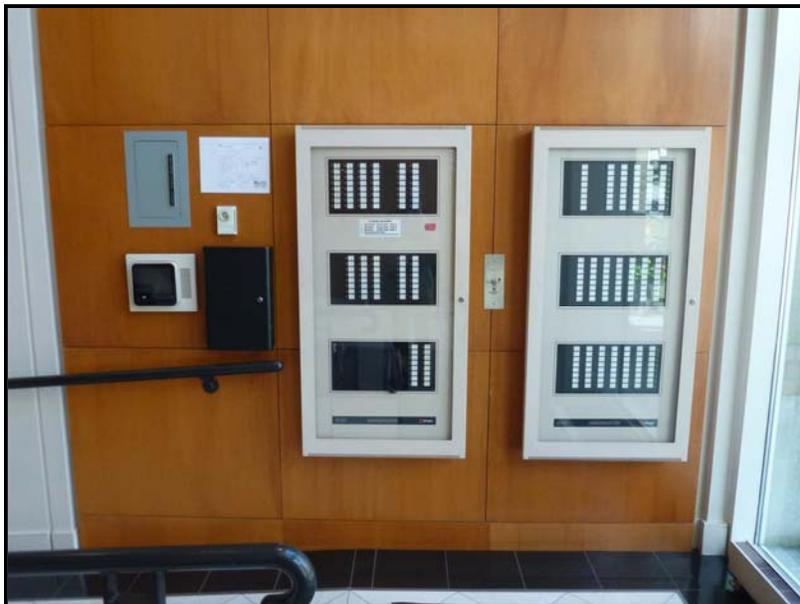
Photo No. 14: Fire alarm annunciator panel (Beach Tower lobby)

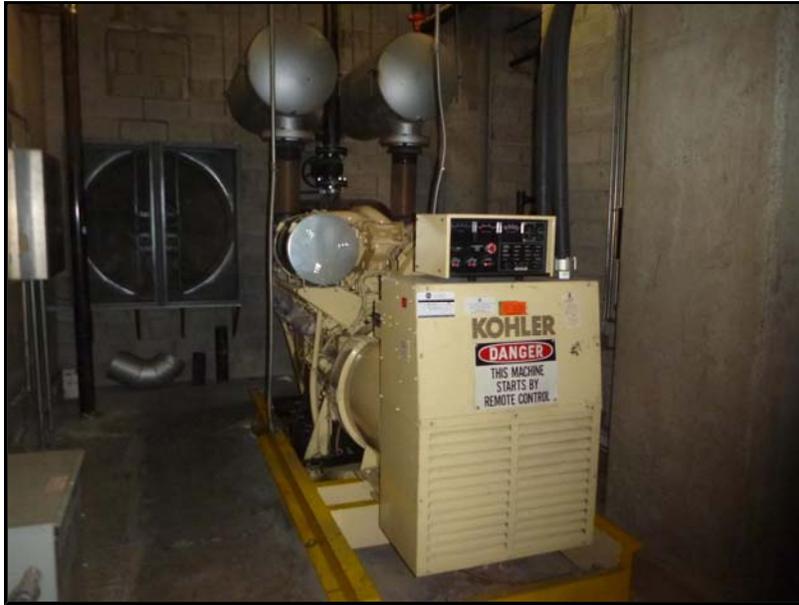
Photo No. 15: Emergency generator (P1 level generator room)

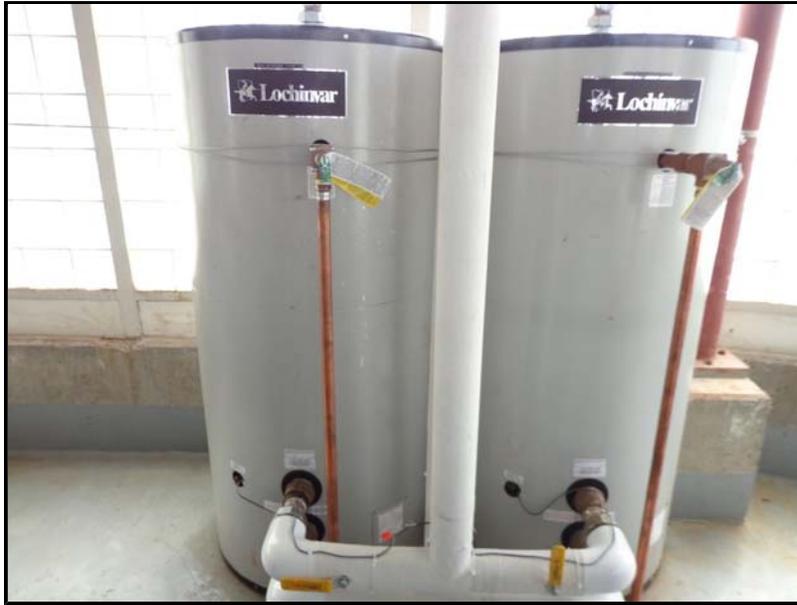
Photo No. 21: Domestic hot water storage tanks (typical)

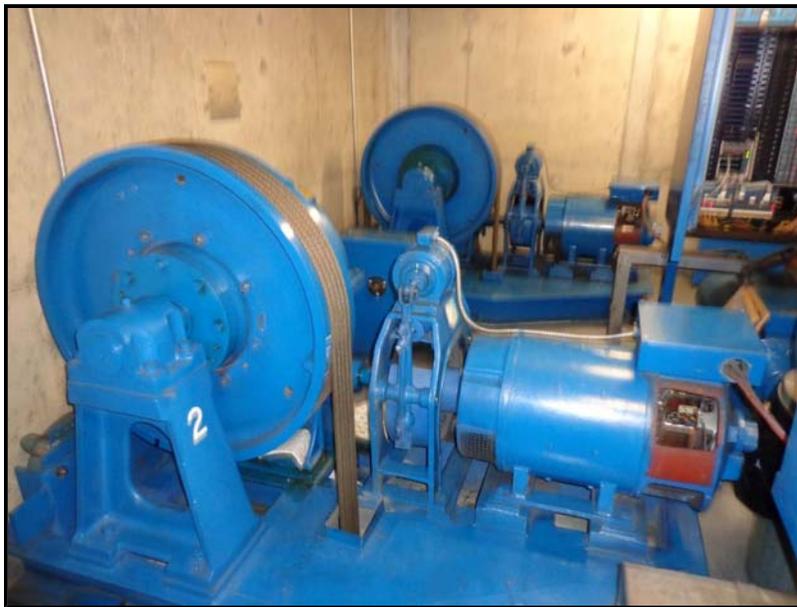
Photo No. 24: Elevator machines (typical)
