**3436.081**  
**888 Beach Avenue**  
**Maintenance & Renewals**  
**2015**

REGARDING **Water Ingress at Main Entrance**

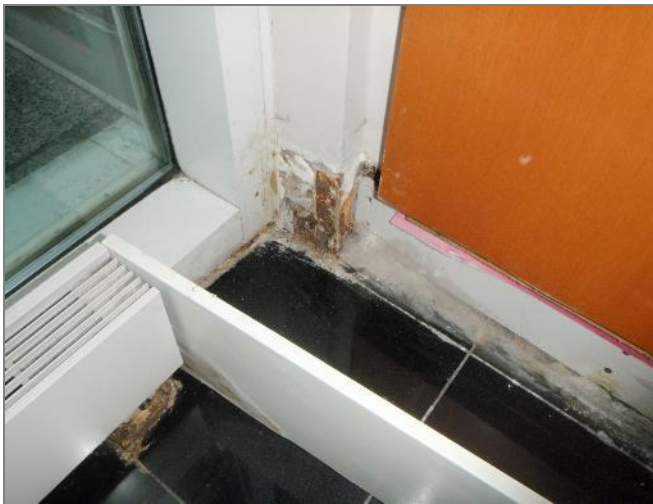
RDH first investigated the leakage at the base of the curtain wall in the Beach Tower lobby in 2007 (Figure 1). A simple flood test was performed at the base of the curtain wall (the surface of the exterior granite tiles were flooded) (Figure 2). Water leaked into the lobby. Upon inspection, it was determined that the bottom of the curtain wall was not sealed to the waterproof membrane under the granite tile. RDH arranged for a contractor to install a sealant bead between the base of the curtain wall and the concrete curb below as per typical curtain wall termination details. This repair was intended as a temporary repair until the waterproof membrane below the granite tiles was replaced.

*Figure 1 – Damaged gypsum sheathing and wood paneling at north side of lobby.*

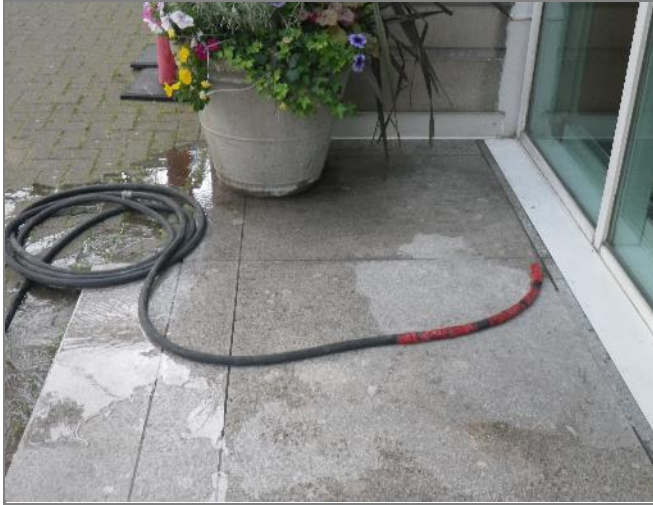
*Figure 2 – Flood testing on granite tiles.*

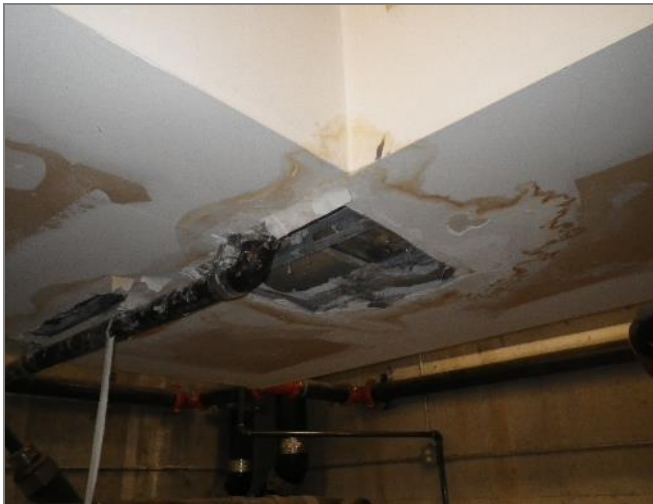
During the investigation, it was also determined that a large quantity of water had been leaking into the mechanical space below the lobby (Figure 3).

*Figure 3 – Leakage into mechanical space below lobby.*

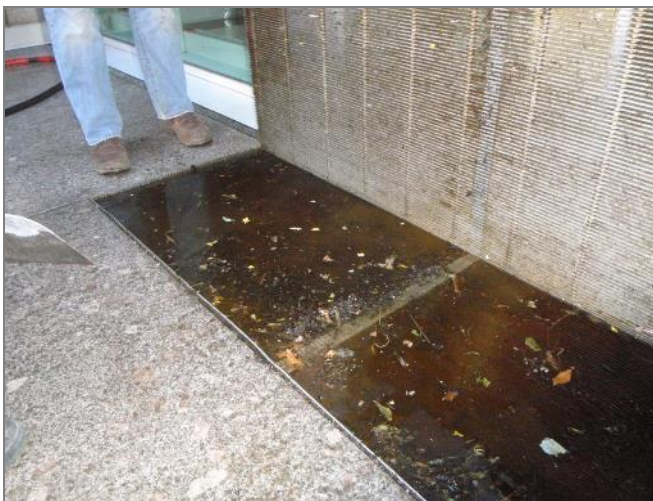
Inspection of the grate at the main entrance determined that the drain was plugged and leakage was occurring through the pan below the grate (Figure 4).

*Figure 4 – Pan below grate at main entrance.*

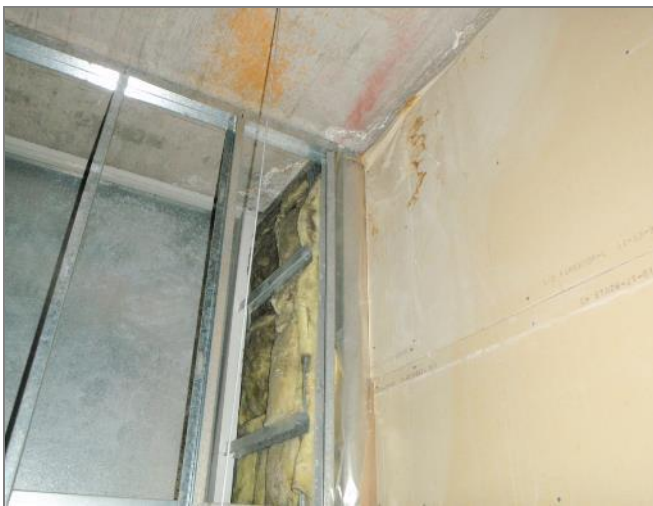
While above the ceiling in the lobby, water stains were noted at the curtain wall to brick interface (Figure 5).

*Figure 5 – Staining at brick to curtain wall interface above leakage location into lobby. This leakage path was confirmed through testing. Note, the staining was present before the testing was initiated.*

*This photograph was taken above ceiling in lobby entrance.*

As a result of our leak investigation, the seal between the curtain wall and the brick clad wall areas was improved. Simultaneously, a new waterproof membrane was installed at the balcony of Suite 511 because water from this source was likely entering the wall below (above the leakage location). Also, the membrane at Suite 511 had been poorly installed. The required work was completed by TEK Roofing.

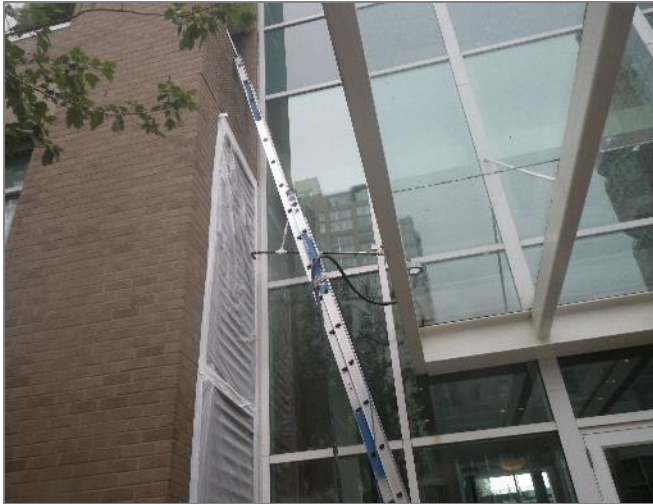
RDH worked with a contractor to have an additional access hatch installed into the ceiling closer to the point of water ingress. Once the hatch was in place, a series of water tests were performed at the curtain wall to brick interface (Figure 6). Water ingress occurred during this testing. The water wetted the previously stained areas and wetted the lobby in the damaged area.

*Figure 6 – Water penetration testing was performed at the brick to curtain wall interface immediately above leak location in lobby. The exhaust grate was covered in poly during test to confirm it was not the point of ingress.*

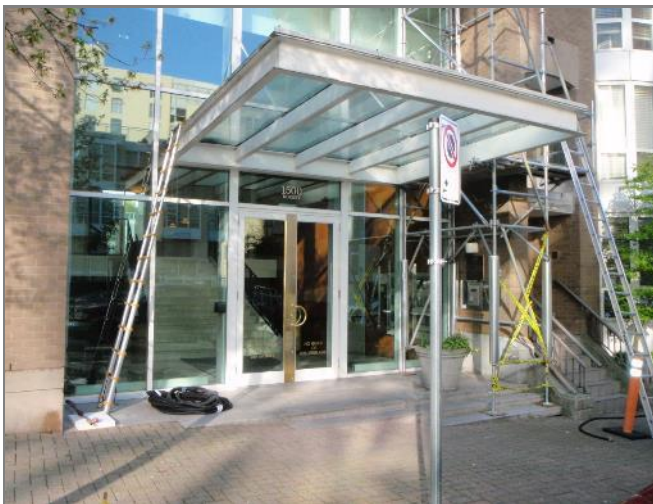
Unfortunately, the leakage into the lobby continued after the curtain wall to brick interface was remediated. Further water testing was performed at the canopy level to try and determine the source of the water ingress. Also, the curtain wall above the canopy was flood tested. This testing resulted in water bypassing the gutter at the canopy to curtain wall interface, but leakage did not occur into the lobby.

*Figure 7 – Water testing at canopy.*

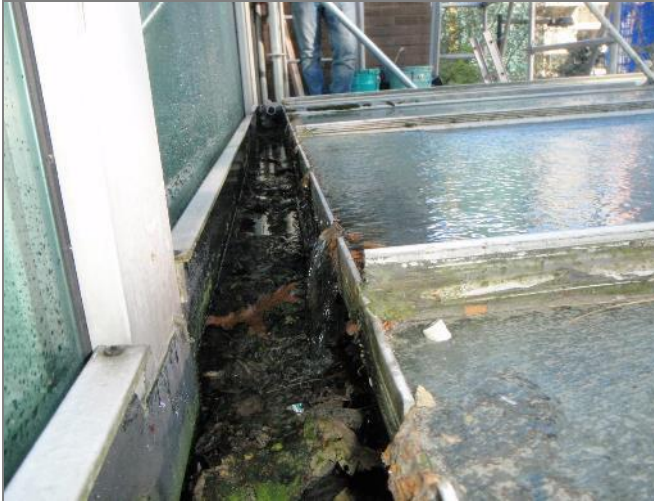
*Figure 8 - Water testing of canopy.*

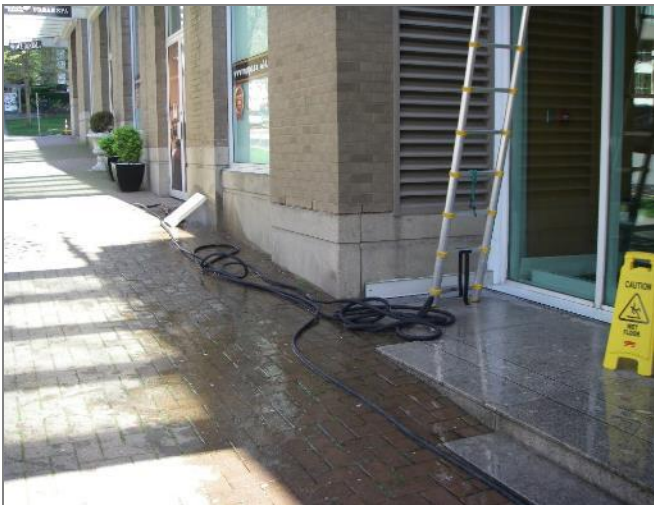
Water testing was continued at the curtain wall to brick interface low on the wall and at the base of the curtain wall. The test area was expanded to the brick paving stones on the sidewalk. Once the testing extended uphill (north) on the side wall, leakage occurred into the lobby.

*Figure 9 - Flood testing along sidewalk.*

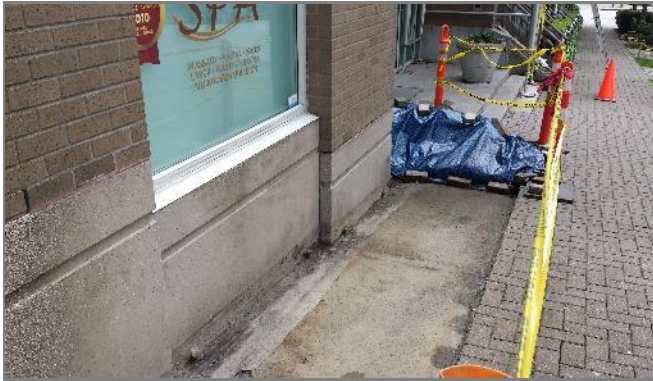
RDH arranged for a contractor to remove the brick paving stones and expose the waterproof membrane (the structural slab above the parking structure extends approximately 4 feet out under the brick paving stones on the sidewalk). Figure 10 illustrates the exposed membrane.

*Figure 10 – Brick paving stones have been removed to expose the base of wall at west sidewalk.*

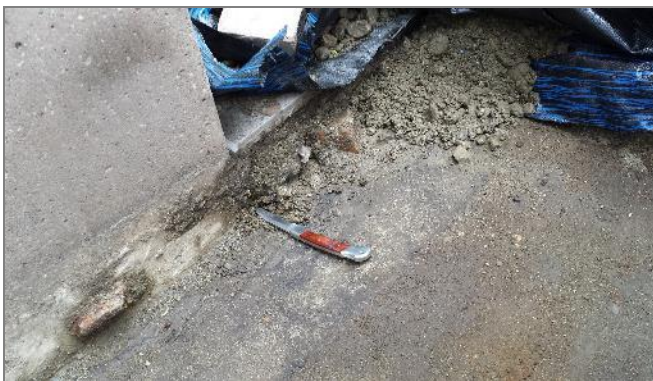
- The granite tiles are installed on a low-strength concrete slab, which is installed over a bed of rubble (sand, gravel, bricks, etc.). Therefore, water can flow under the granite tiles and under the concrete topping (Figure 11).
- The concrete at the base of the building is pre-cast elements. The waterproof membrane from the structural slab extends up behind the pre-cast elements. There is water under the membrane at the edge of the pre-cast elements (Figure 12).

*Figure 11 – Granit tile at main entrance is set on a low-strength concrete slab, which is sitting on a bed of rubble.*

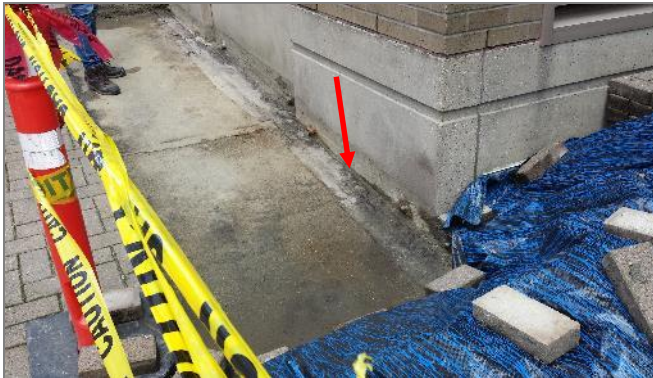
*Figure 12 – Waterproof membrane extends under the pre-cast slab. The arrow indicates a location where there is water under the membrane.*

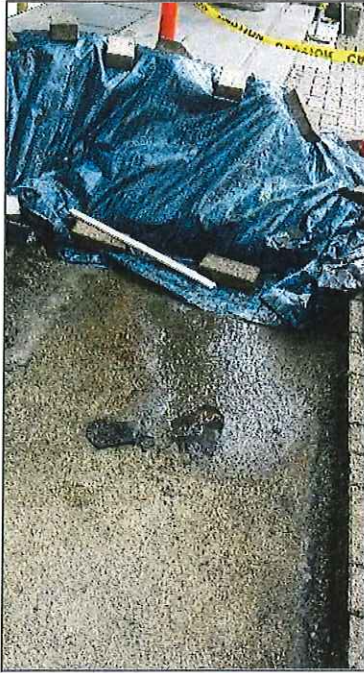
→ There is extensive water under the membrane on the structural slab (Figure 13).

Figure 13 – Water under membrane on podium slab.

Based on our current observations and testing, water is getting in behind the pre-cast elements and traveling laterally into the lobby. Unfortunately, correction of this problem is not easy. We will provide a recommendation shortly. Also, we have been unable to confirm a leakage source that has caused the staining on the south side of the lobby adjacent to the curtain wall.
