To: The Owners, Strata Plan LMS712  
c/o John Boschert, Senior Strata Agent  
FirstService Residential  
700 - 200 Granville Street  
Vancouver BC V6C 1S4

Submitted: December 6, 2024, by  
RDH Building Science Inc.  
4333 Still Creek Drive #400  
Burnaby BC V5C 6S6

**Building Enclosure Condition Assessment Report** | Project 3436.095  
888 Beach, 888 Beach Avenue, 1500 Hornby Street, and 1501 Howe Street, Vancouver, BC

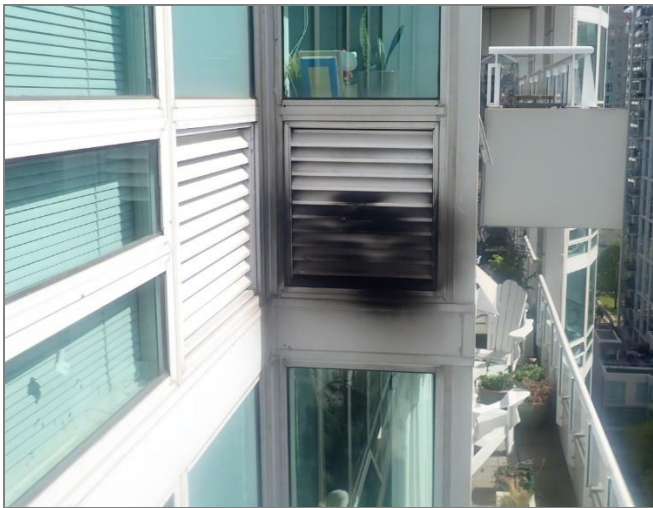
The gas fireplaces are directly ducted to the exterior either directly through the exterior cladding and windows or via bulkheads below the ceiling. At the exterior, significant staining is visible at several gas fireplace exhaust vents. The staining is indicative of a fireplace operating at low efficiency and improper combustion (Figure 5.4 and Figure 5.5). The fireplaces should be reviewed and repaired as part of regular maintenance.

*Figure 5.4*  
*Stained fireplace vent.*  
*Beach Tower, Suite 1901, east elevation.*

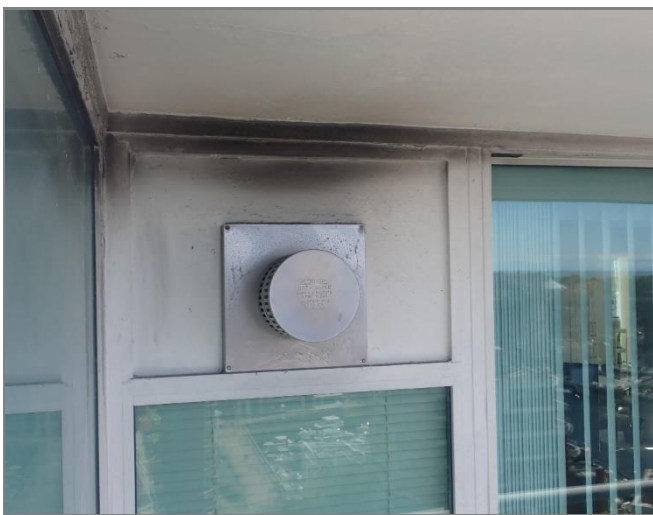
*Figure 5.5*  
*Stained fireplace vent.*  
*Ocean Tower, Suite 303, west elevation.*

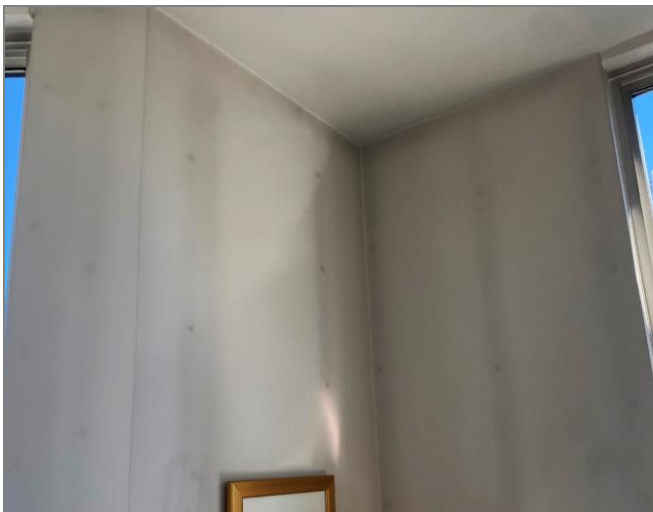
*Figure 5.7*

At Suite 2103, there are localized condensation stains along the interior drywall due to thermal bridging of the steel studs (Figure 5.7). Thermal bridging occurs when one part of the building enclosure assembly is more thermally conductive than the surrounding area, creating a path of least resistance for the transfer of thermal energy, resulting in localized cold surfaces and condensation.

*Thermal bridging stains on interior drywall at Suite 2103, Beach Tower.*

- 1) Improving general ventilation. Operating fans in the bathroom and kitchen and opening windows to exhaust humid air from the suite.
- 2) Improving circulation of heat and air. Drapes and furniture placed in front of windows can limit the circulation of warm air at these locations, limiting the potential for drying. Also, ensuring the suite heating system is used to maintain temperatures within the recommended range.
- 3) Improving the thermal resistance of the building enclosure. Better enclosure assemblies and components, such as concrete walls and windows with improved insulating qualities will not be as cold and may experience less condensation.

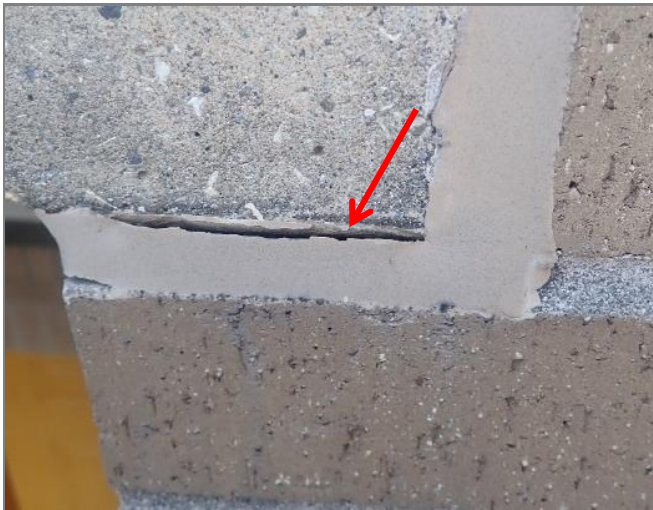
*Figure 5.11*

- The exterior sealants at the brick veneer cladding were renewed in approximately 2020. There are localized areas where the sealant has failed and debonded from the substrate (Figure 5.11).

*Failed sealant at brick veneer wall.*

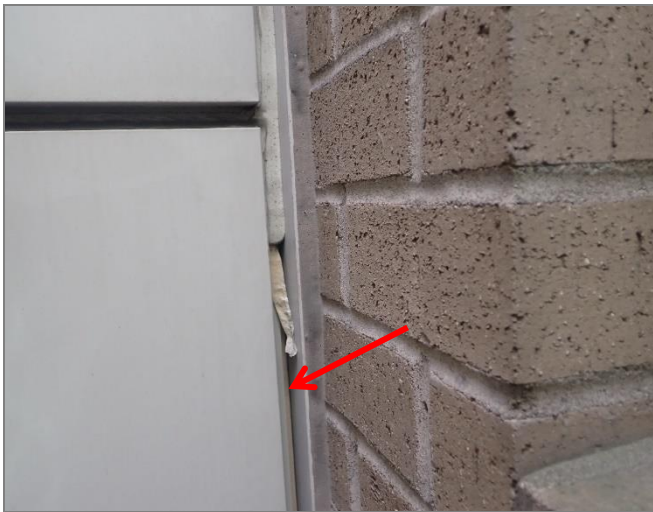
*Figure 5.12*

- There was a section of missing sealant between the brick veneer cladding and prefinished metal panels adjacent to Suite 301 (Figure 5.12).

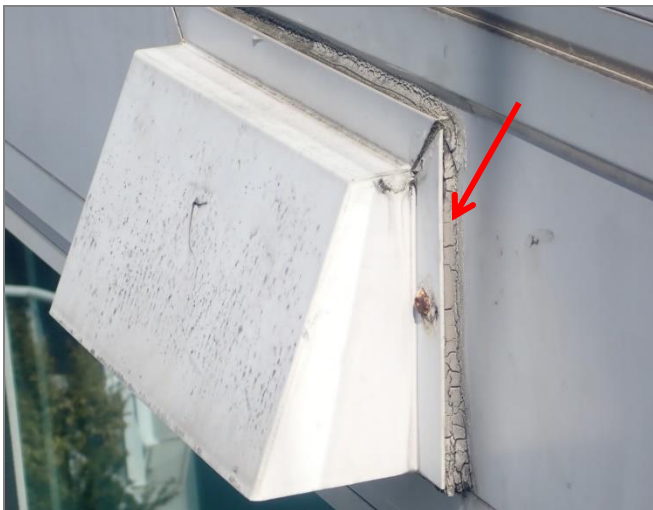
*Figure 5.13*

- The sealant at vent hood flashings was cracked and deteriorated at several locations throughout the complex (Figure 5.13).

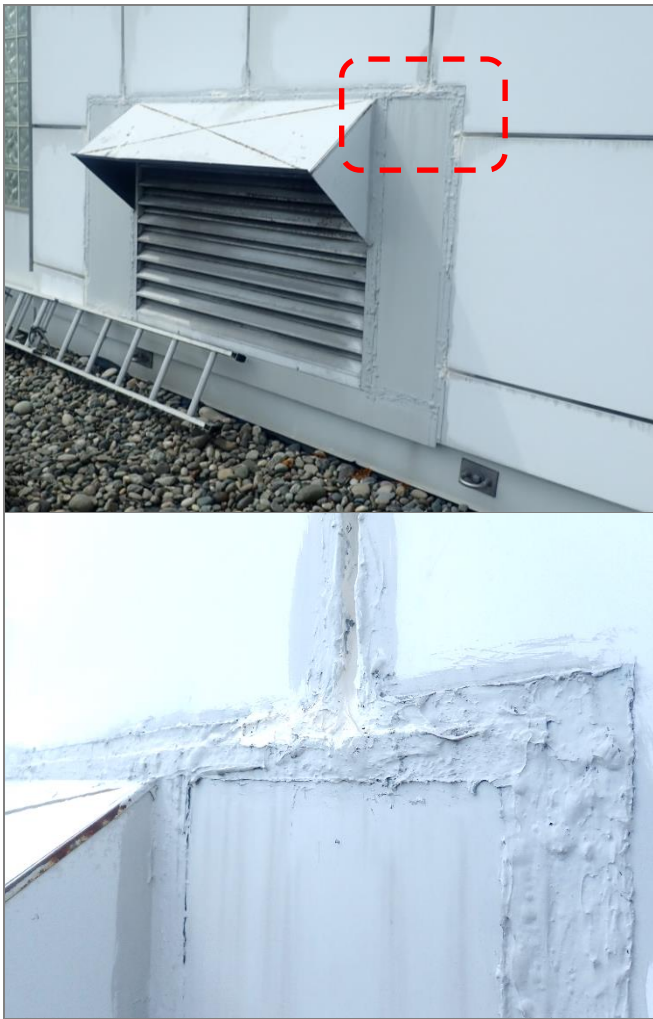
*Figure 5.14*

- At the roofs of Beach Tower and Ocean Tower, the perimeter sealant at the air handling unit louvers were roughly troweled along the metal panel and there appeared to be multiple blisters and voids along the sealant joints (Figure 5.14). The repairs to have been done by others and not part of the comprehensive sealant renewal project.

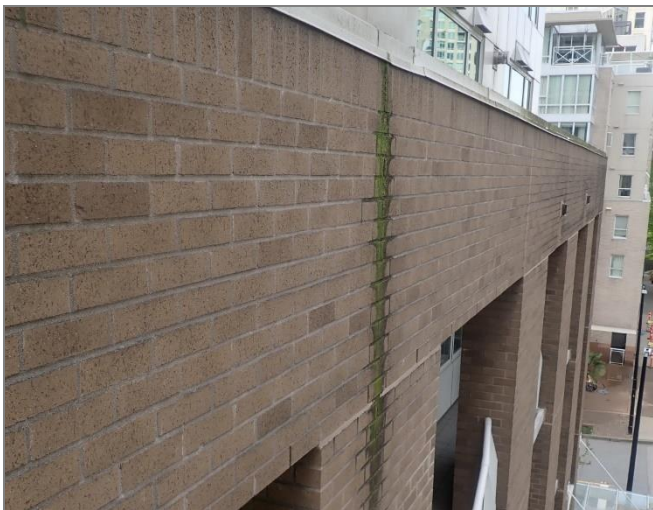
*Figure 5.15*

→ There are localized areas where the brick veneer walls are stained from concentrated water runoff at the cap flashings above (Figure 5.15).

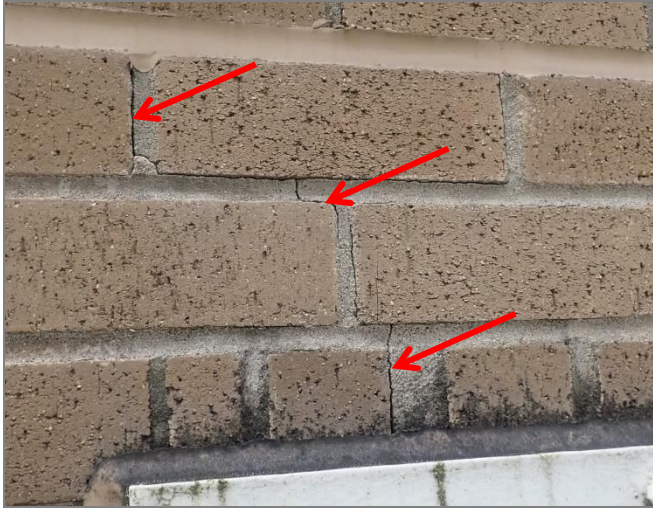
*Figure 5.16*

→ There are localized step cracks in the mortar joints at brick veneer walls (Figure 5.16).

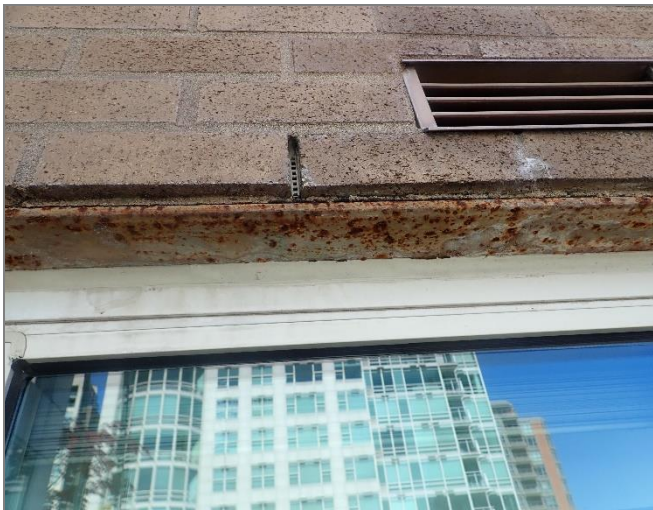
*Figure 5.17*

→ There is surface corrosion on the brick veneer steel shelf angles (Figure 5.17).

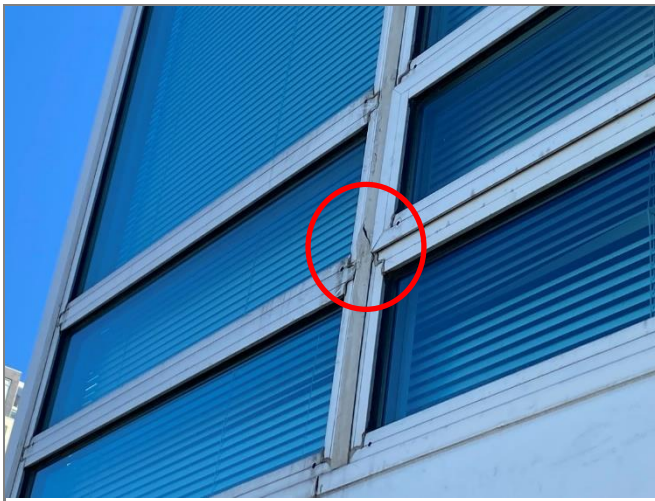
*Figure 5.28*

- There were localized areas where the exterior silicone strip seals were damaged or not adhered to the window frame substrate (Figure 5.28 and Figure 5.29).

*Damaged silicone seal.*

*Ocean Tower, Suite 701, south elevation.*

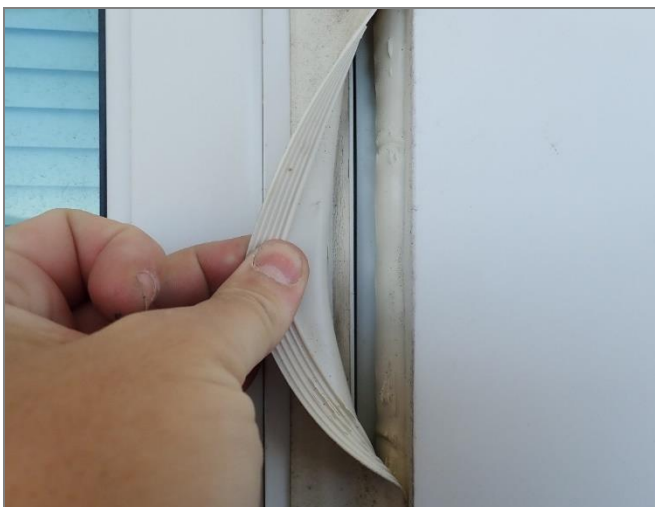
*Figure 5.29*

*Beach Tower, Suite 3301, west elevation.*

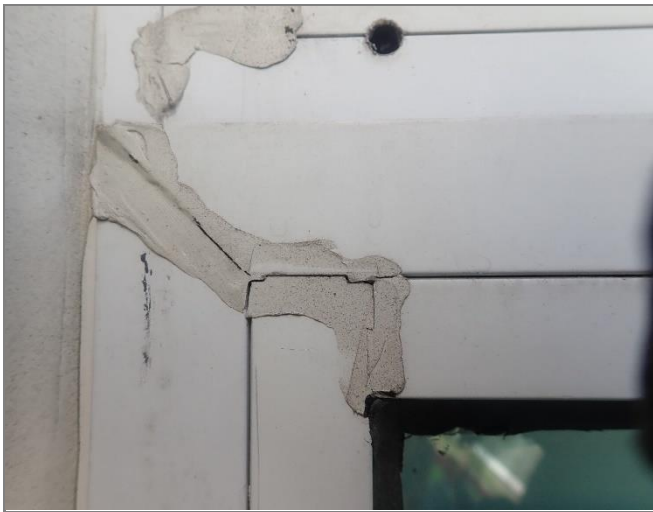
*Figure 5.30*  
Cracked sealant at window mitre joint.  
Garden Tower, Suite 516, south elevation.

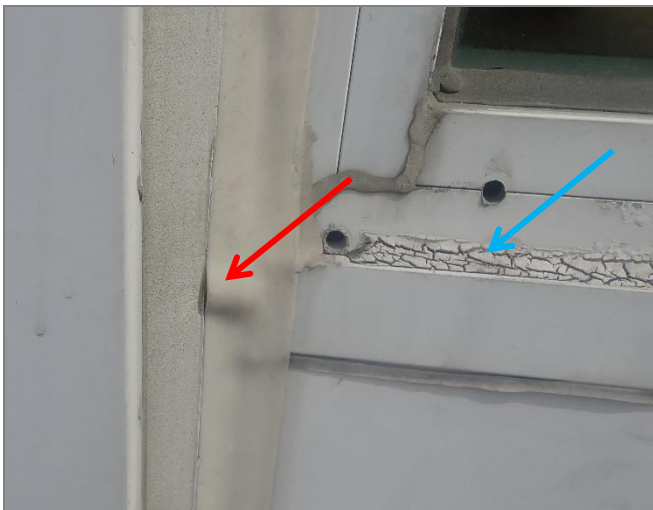
*Figure 5.31*  
Void in silicone strip (red arrow).  
Note that the original sealant (blue arrow) has deteriorated.  
Beach Tower, Suite 906, south elevation.

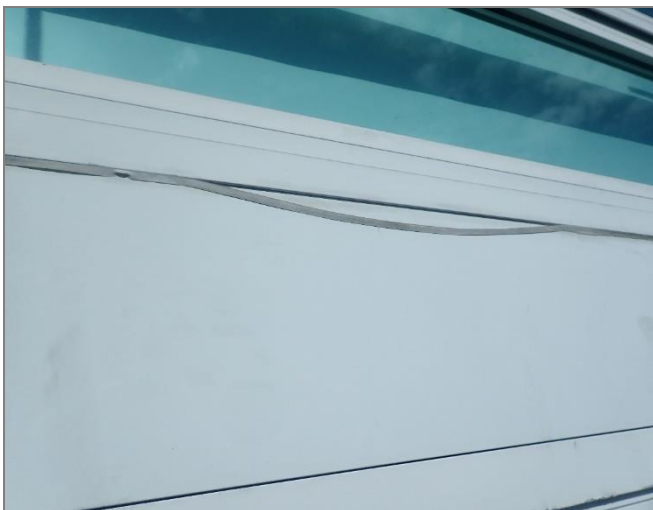
*Figure 5.32*  
Sealant adhesive failure.  
Ocean Tower, Suite 1302, south elevation.

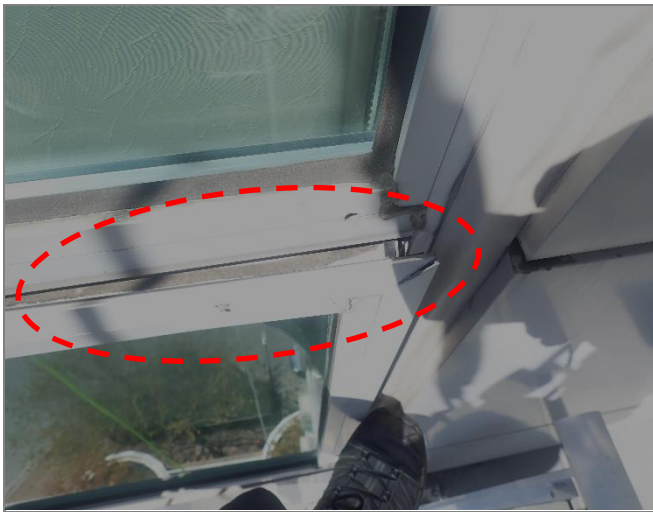
- Several operable awning windows have misaligned hinges resulting in gaps at the top of the windows (Figure 5.34 and Figure 5.35). Some windows have damaged or missing handles (Figure 5.36). Damaged window hinges or handles prevent the windows from closing properly and will result in drafts and heat loss during the winter.

*Figure 5.34*  
Misaligned window vent.  
Ocean Tower, Suite 1002, east  
elevation.

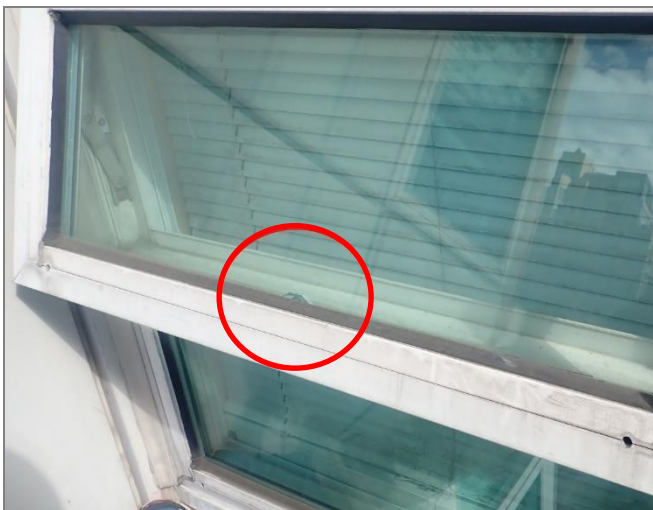
*Figure 5.36*  
Damaged operable window  
handle.  
Ocean Tower, Suite 901, west  
elevation.

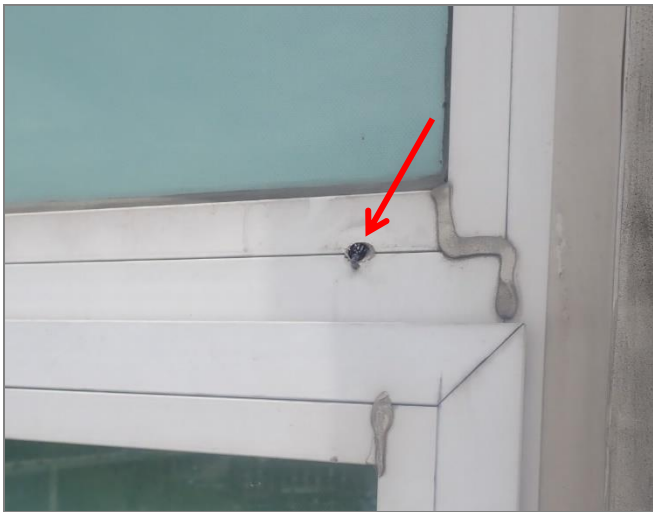
*Figure 5.37*

→ Some of the weepholes at window frames appeared to be partially obstructed with debris (Figure 5.37).

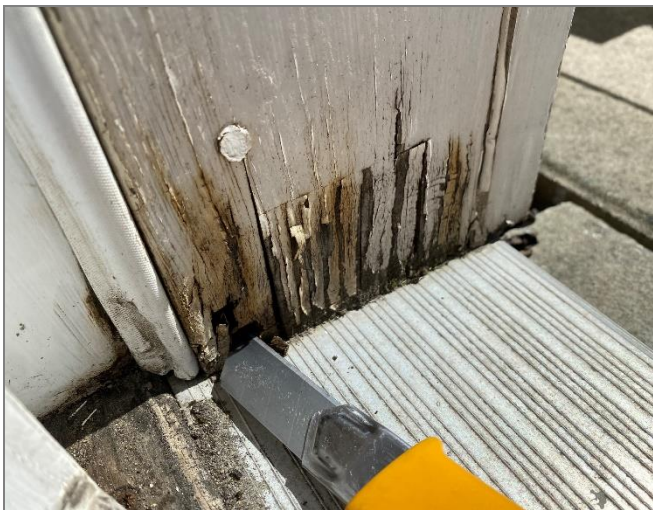
*Figure 5.38*

- The existing original swing door wood frames at townhouse balconies and decks have localized water damage at the base of the wood frames (Figure 5.38).

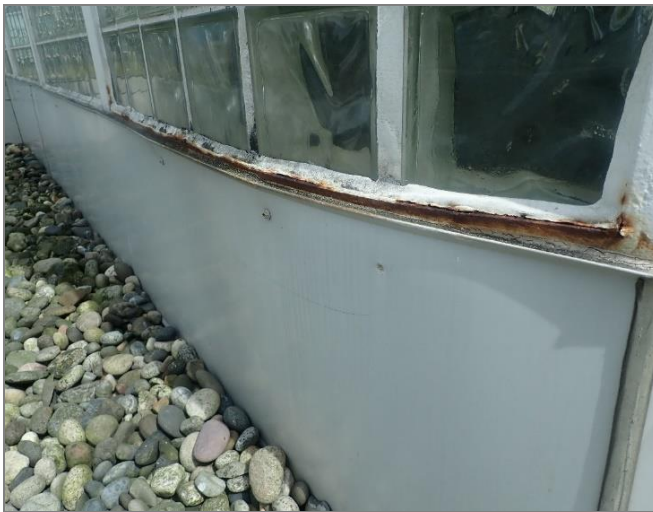
*Figure 5.39*

- The perimeter steel frames at most of the glass block windows are locally corroded along the bottom edges and at corners (Figure 5.39 and Figure 5.40).
- The glass masonry unit is cracked at the bottom corner of the glass block window at Suite 301 (Figure 5.40).
- Localized concerns at glass block walls should be addressed by targeted maintenance repairs to replace damaged glass blocks and treat frame corrosion, as required.

*Corroded glass brick frame,  
Garden Tower roof.*

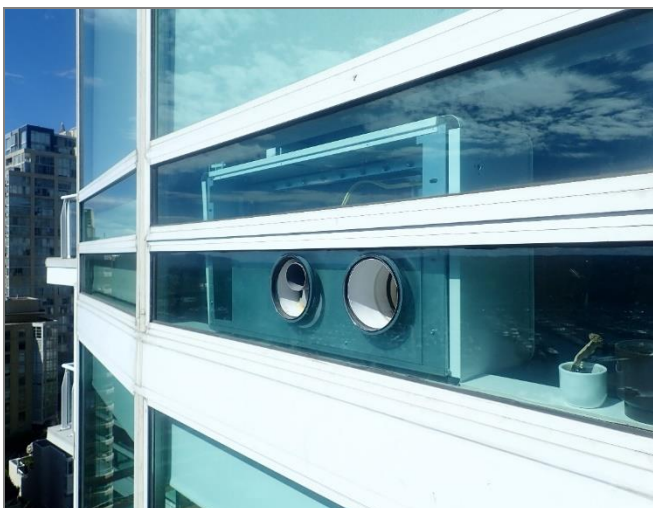
*Figure 5.41*

- Localized suites are using air conditioning units for cooling in summer months. Some air conditioners have been permanently installed with penetrations through the window IGUs. However, at Suite 1601, the air conditioner penetrations do not appear to include water shedding provisions and have an increased risk of water ingress during rain (Figure 5.41).

Several suites have installed air conditioner units through existing windows. The Owners should consider instituting a design review procedure for new air conditioner installations through windows, including review by a registered professional engineer or architect, for each unique installation.

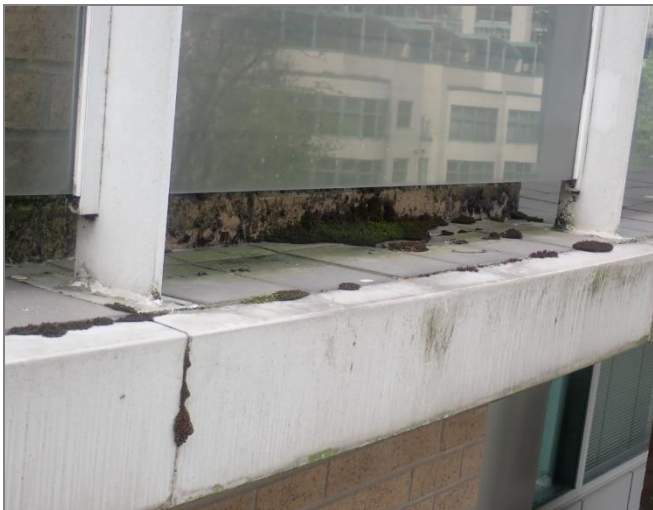
*Figure 5.47*

- There was moss and staining along the metal flashing joints of the tiled balconies (Figure 5.47).

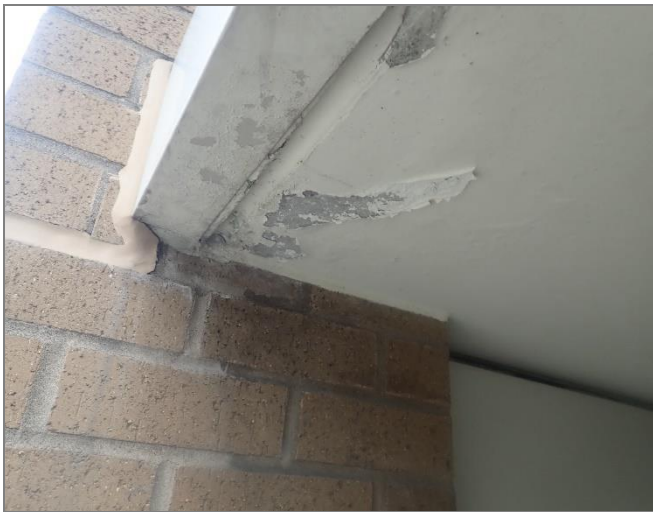
*Figure 5.48*

- There were localized areas of peeling paint, efflorescence, and corrosion of exposed steel reinforcing or embedded formwork nails at the underside of various tiled balconies (Figure 5.48 and Figure 5.49).

*Beach Tower, Suite 410, west elevation.*

- The original tiled balcony edges at the townhouses and exterior walkways are stained and the soffit paint is peeling. These locations should be reviewed in further detail to determine the condition of the underlying concrete at balcony edges.

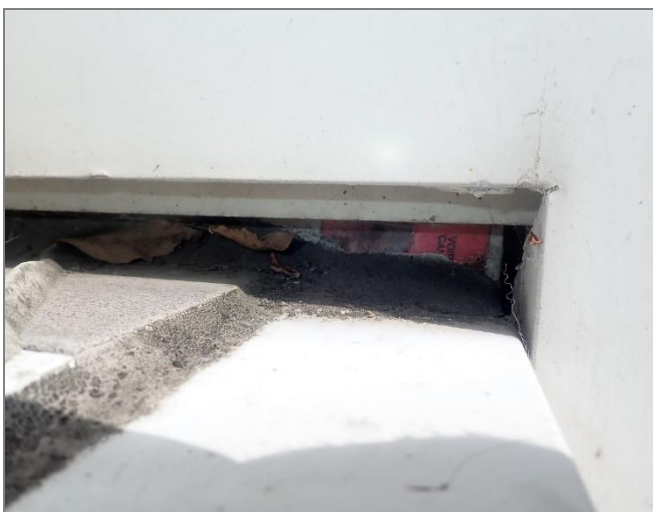
*Figure 5.50*

- At tiled balconies, the sheathing paper and tape were visible through gaps at the saddles of the tiled balconies and the surrounding metal panel cladding (Figure 5.50).

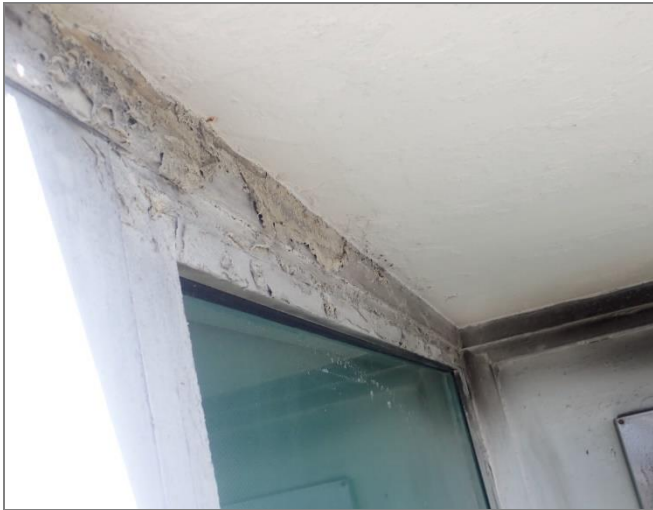
*Figure 5.51*

- There is a localized area of delaminated paint or aluminum finish coating at the balcony of Suite 1501. The exact cause of this damage is unclear but the damaged coating is directly adjacent to a stained black fireplace vent (Figure 5.51).

- Adjacent to a fireplace vent at Suite 1501, an existing window frame coating appears to be locally damaged. This location should be reviewed in more detail to determine the cause of the damage and potential corrective actions.

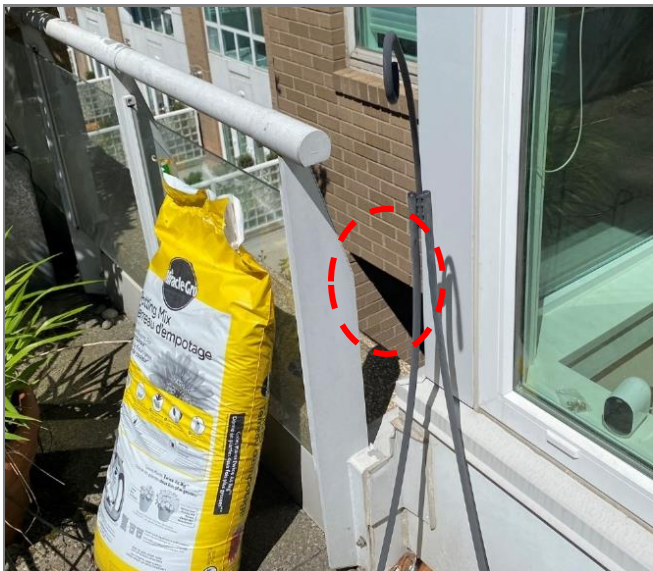
*Figure 5.52*

- At Suite 516, there is a 5" gap between the guardrail and the adjacent glazing assembly (Figure 5.52). Per the VBBL, gaps within guardrails or between guardrails and adjacent assemblies cannot exceed 100 mm (approximately 4").

*The gap exceeds the allowable size for gaps within guardrails or between guardrails and adjacent structures, per the VBBL requirements.*

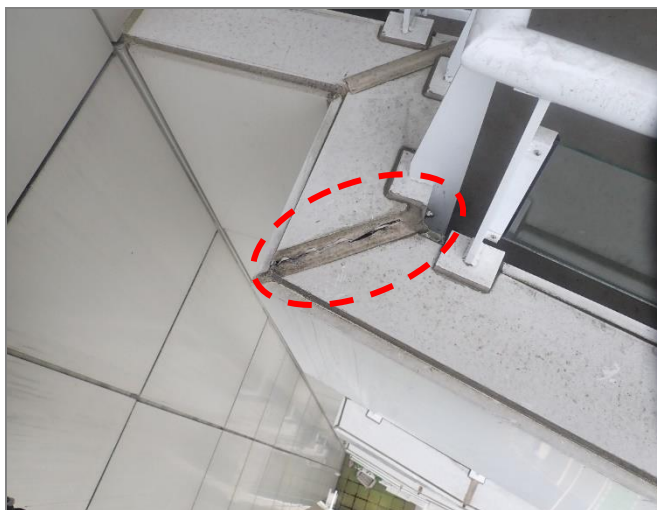
*Figure 5.53*

- Some balconies include steel-framed guardwalls with pre-finished metal cladding panels, which are similar to the metal panel wall cladding. These guardwalls include exposed silicone seals, which were locally damaged at some suites (Figure 5.53).

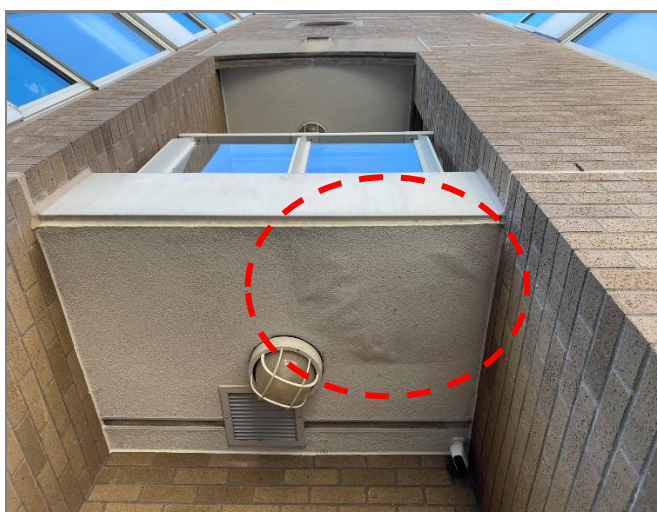
*Figure 5.54*

- The stucco soffits below some balconies were locally stained or water damaged, causing the stucco finish to partially delaminate from the gypsum board substrate. It is our understanding that these areas of localized damage were caused by past water ingress which has been addressed, and the stains have not spread past the original areas. The delaminated portions of the soffit may eventually become a safety concern if left unaddressed.

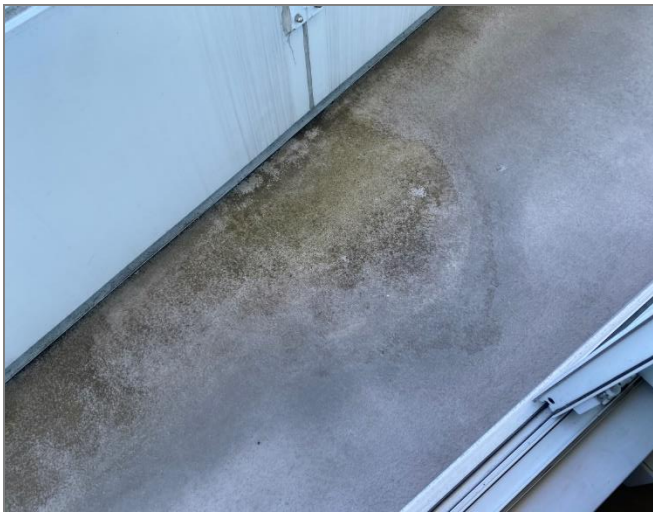
*Figure 5.55*

- Some residents reported localized ponding on their balconies after rain or cleaning (Figure 5.55). Staining was observed on a few of the balconies reviewed.

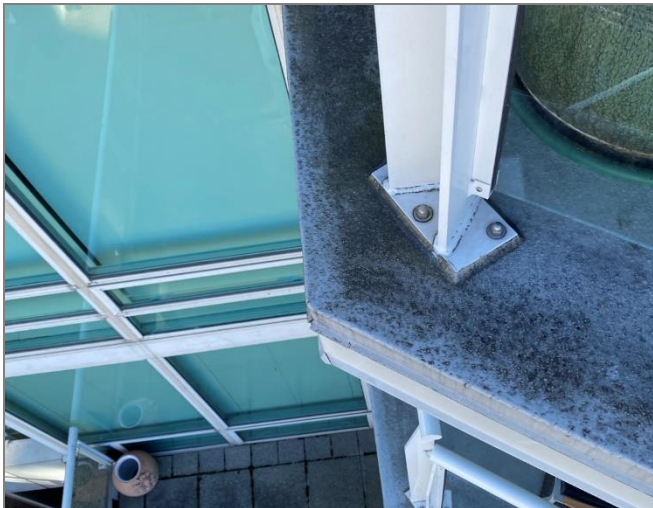
*Figure 5.56*

- The exterior edges of the balcony membranes were stained due to their increased exposure to weathering; however, we did not observe any areas of high wear or membrane deterioration (Figure 5.56).

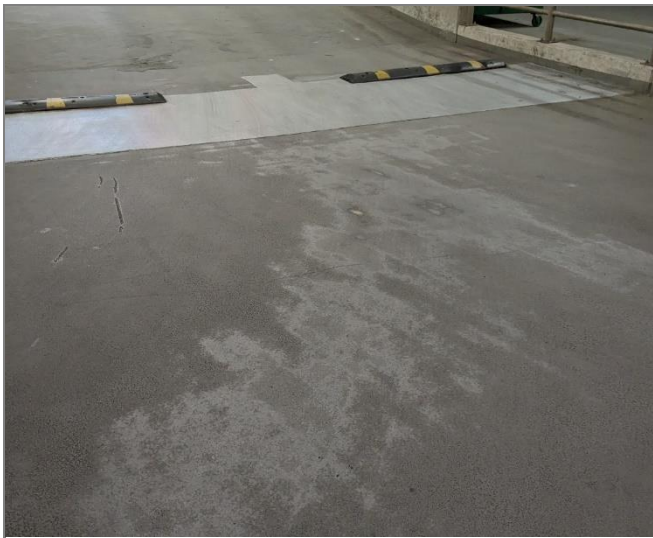
There were several locations within the parkade where the existing traffic coating membrane was worn down to expose the underlying base layer of coating or the concrete substrate. This condition is a common occurrence at high traffic areas, such as parkade entrances, turning lanes, and visitor parking areas (Figure 5.60, Figure 5.61, and Figure 5.62).

*Figure 5.60*  
Existing wear at the traffic bearing membrane at the base of the east parkade entrance ramp.

- The high-traffic areas of the parkade have increased wear and damage to the traffic bearing membrane. If left unaddressed, the damaged areas will continue to expand and eventually delaminate from the concrete substrate. These areas should be repaired as part of maintenance to prevent further damage.

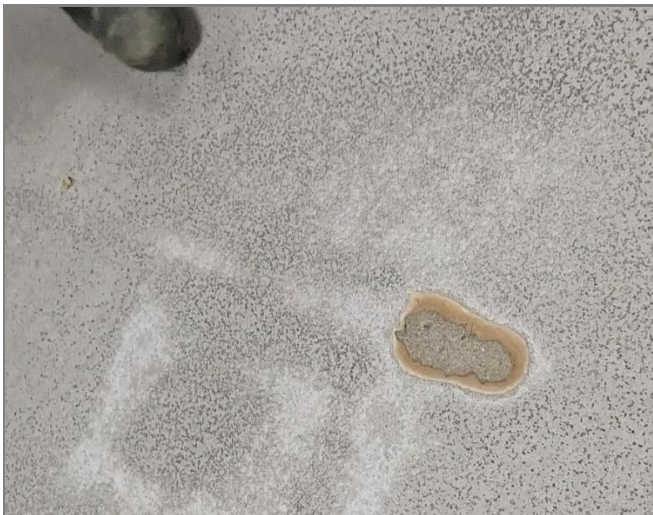
*Figure 5.61*  
Localized exposed concrete substrate at the parkade traffic aisle.  
Parkade Level P1, Visitor Parking area.

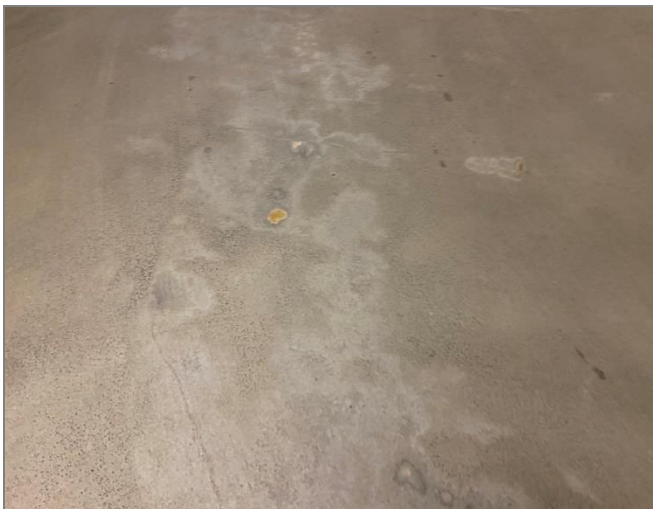
*Figure 5.62*  
Localized exposed concrete substrate at the parkade traffic aisle.  
Parkade Level P2.
