Project: **Tree Transplant Feasibility Study
888 Beach Ave, Vancouver**

Re: **Roof Membrane Replacement Project**

ACL File: 21249

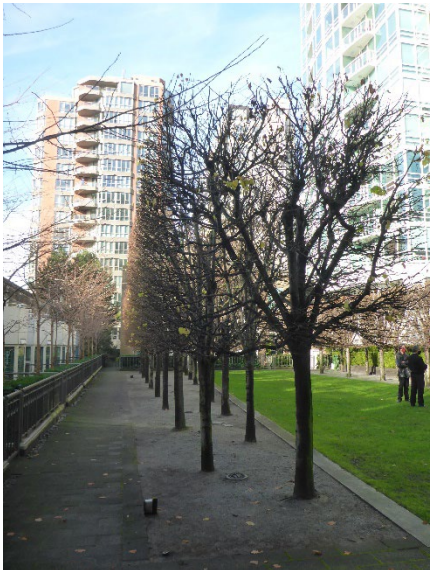
Site Visit Date: Nov 26, 2021 Root Mapping and Soil Property Investigation		
Photo A. West side of the rooftop looking north.	Photo B. Root mapping excavation with rock edge and adjacent soil and grass.	Photo C. Root mapping within adjacent softscape with tree in background

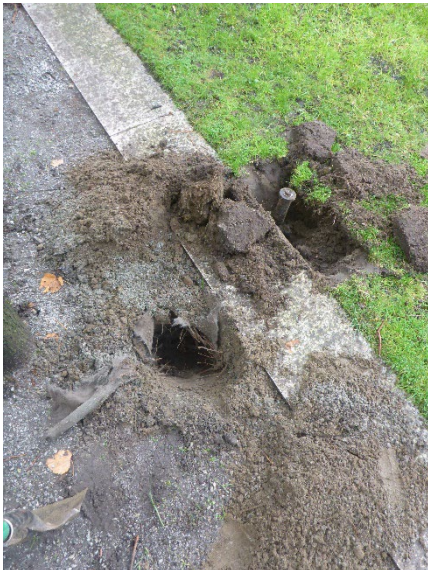
2. Root mapping at the extent of the old rootballs resulted in findings that the old burlap sacs that wrapped the rootballs (from the balled and burlapped nursery preparation) was still intact and the burlap had not disintegrated/biodegraded over time. Roots grew around the old burlap, but not through it. In typical landscape soils, untreated burlap sacs are apt to disintegrate within 1-3 years from the soil biology and chemistry breaking down the fibres. The burlap did not appear to be treated nor did it appear to be synthetic, both conditions that would result in the burlap not being degraded over time by soil chemistry and biology, and weather. The infertility of the sand in the surrounds of the original rootballs was the likely primary contributing factor that the burlap remained intact and substantiates the infertility as it relates to the lack of observed root growth outside of the original rootballs.

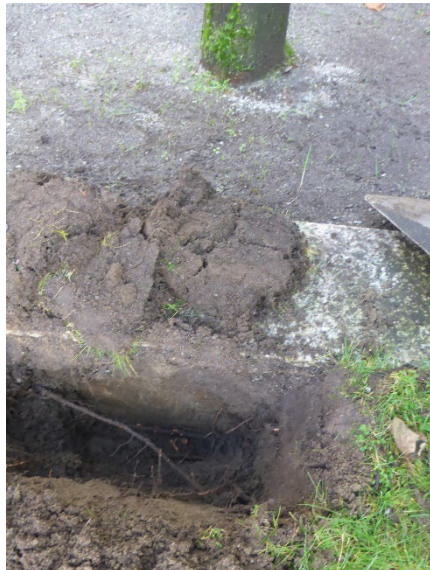
3. The largest woody roots found outside of the original rootballs were 1 to 2 cm \varnothing and were found to be growing from the nearest trees specifically below the rock edge and into the soils where the turfgrass grows. This is an opportunistic root growth strategy whereby the nutrition, water, and oxygen has enabled initial resource collection for the trees, but those roots are not well established at this stage.
