DOMESTIC WATER SYSTEM CONDITION ASSESSMENT

STRATA PLAN LMS 712

Presented to:	Mr. John Boschert FirstService Residential #700 – 200 Granville Street Vancouver, BC. V6C 1S4
Proponent/ Prepared By:	McCuaig & Associates Engineering Ltd. Suite 200 - 3999 Henning Drive Burnaby, BC V5C 6P9
Date :	April 19, 2023
MAE Ref. No.:	20201136-C-RPT-RPT-01-REV1-FNL
	EGBC 1002833

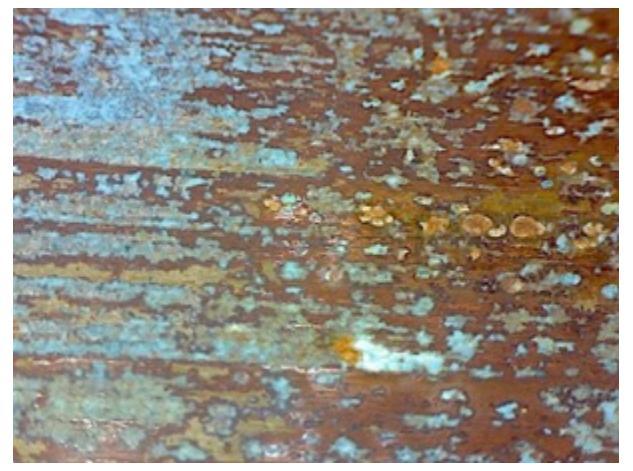
Photo 3. Sample B – P2 Mechanical DCW

An example of uniform corrosion is seen in Sample B, C, E, and F (refer to Photos 3, 4, 5, 6, 9, 10, 11, and 12). Uniform corrosion is a general form of corrosion where the entire surface of the pipe wall is thinning at a uniform rate. Tarnished copper surface and shallow narrow pits characterize uniform corrosion and cold water pitting respectively.

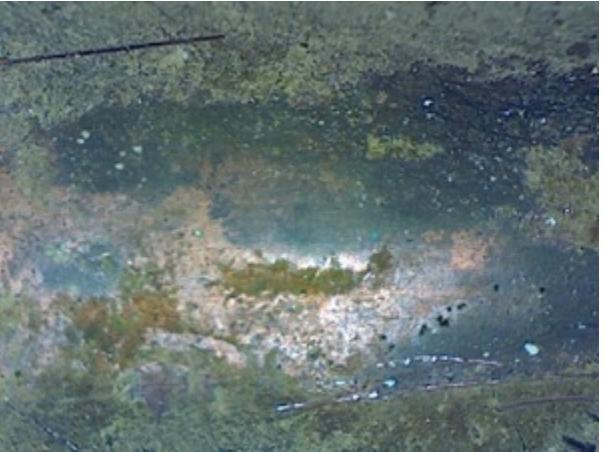
Photo 20. Sample J – Uniform corrosion with moderately severe pitting

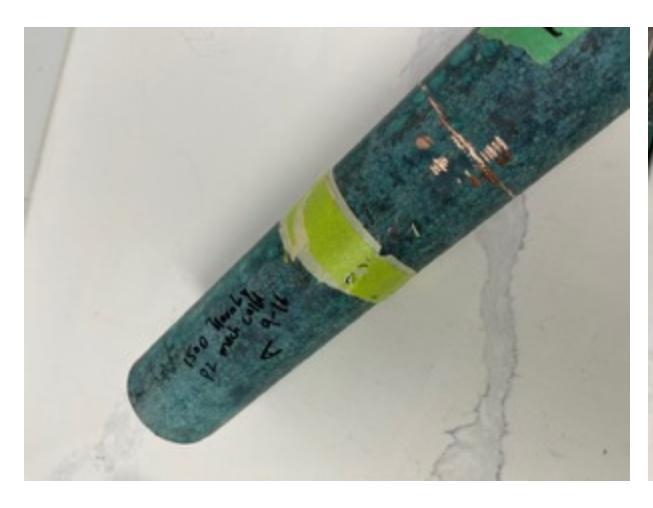
Photo 47. Sample A – Corrosion on Exterior

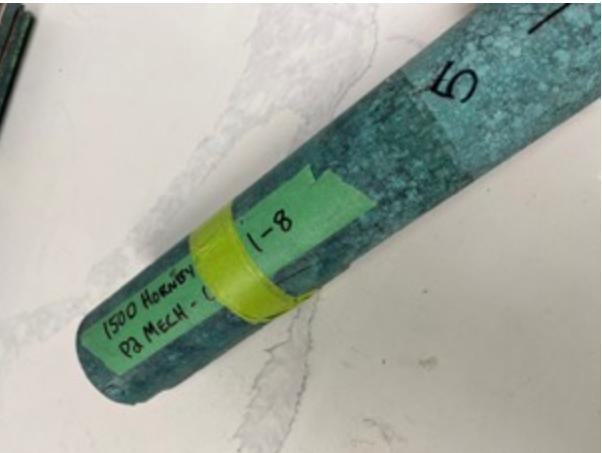
Photo 48. Sample B – Corrosion on Exterior

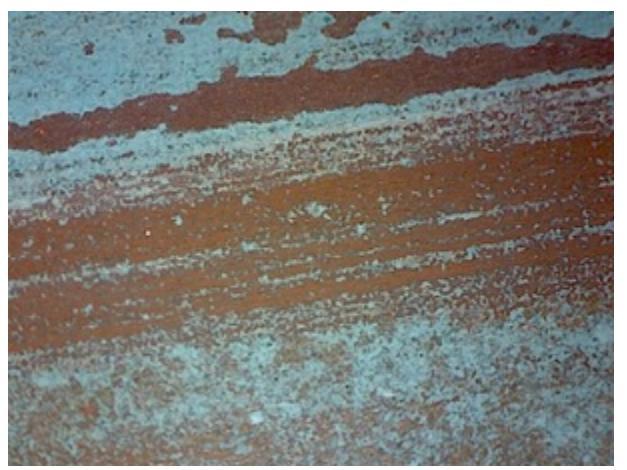
Photo 54. Sample C – Uniform corrosion with velocity wear

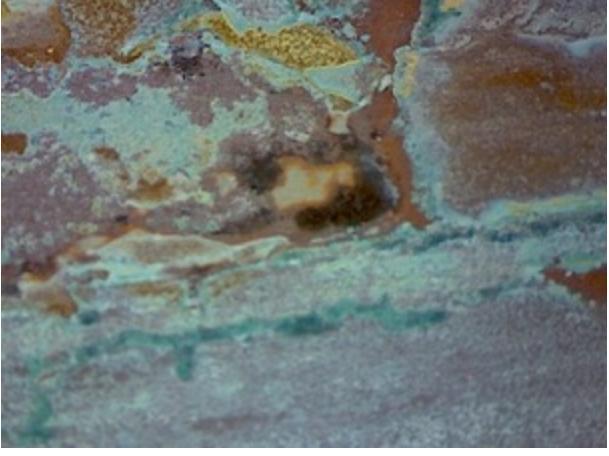
Photo 56. Sample D – Uniform corrosion with moderately severe pitting

An example of uniform corrosion and cold water pitting is seen in Samples D, F, G, and K (refer to Photos 55, 56, 59, 60, 61, 62, 69, and 70). Uniform corrosion is a general form of corrosion where the entire surface of the pipe wall is thinning at a uniform rate. Tarnished copper surface and shallow narrow pits characterize uniform corrosion and cold water pitting respectively.

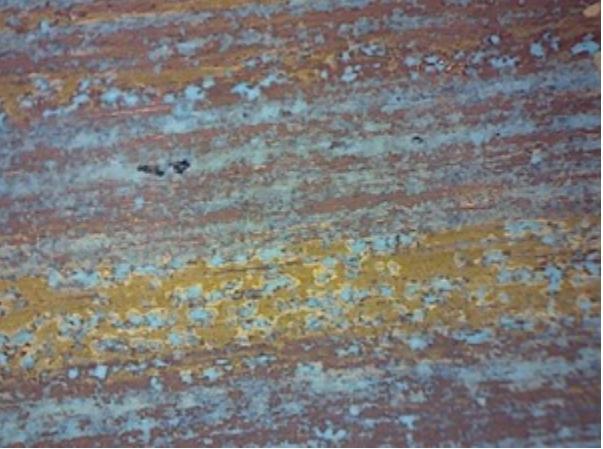
Photo 62. Sample G – Uniform corrosion with moderate pitting and velocity wear

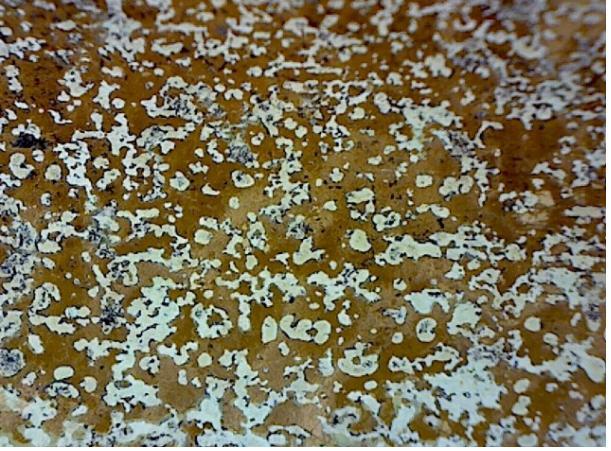
Photo 74. Sample M – Uniform corrosion with moderate pitting

Manifolds Sample L and M both showed uniform corrosion with moderate pitting on the pipe interior (refer to Photos 71, 72, 73, and 74). Sample M did not show any signs of pinhole leaks on the pipe exterior. Connections of the plastic pipes to manifolds were in fair condition without any signs of leaks, and no discoloration was observed. Sample L on the other hand, showed localized corrosion in greenish color on pipe exterior. Also, black discoloration of the pipe exterior was observed, and this may be an indication that the pipe is in contact with other non-compatible metals such as galvanized steel.

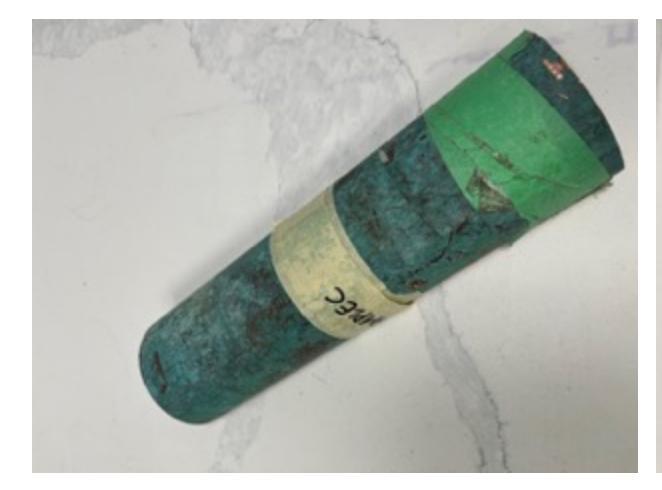
Photo 75. Sample C – Corrosion on Exterior

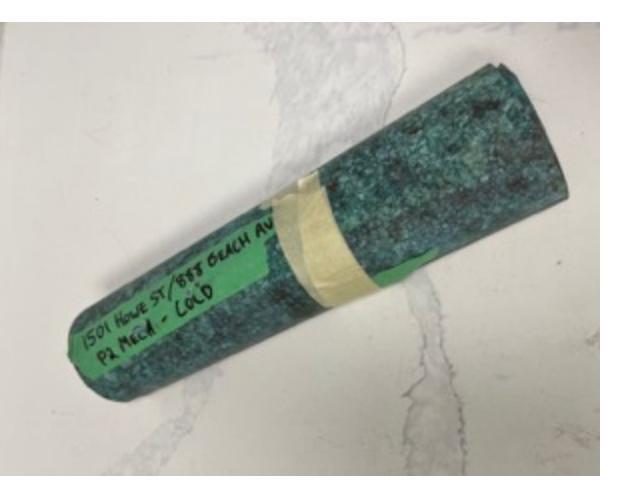
Photo 76. Sample D – Corrosion on Exterior

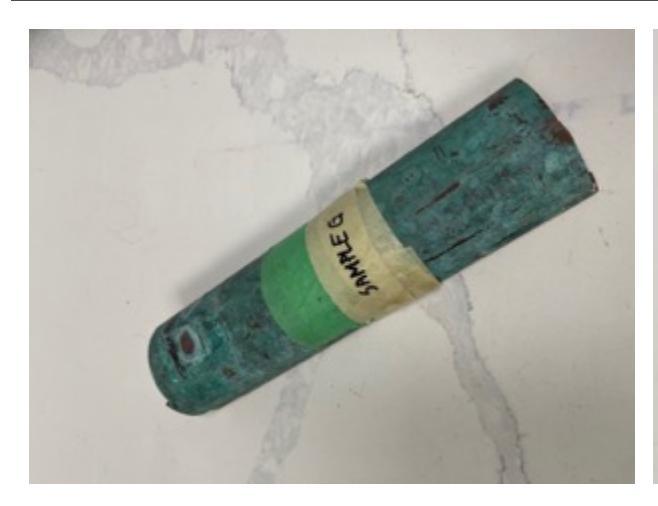
Photo 77. Sample G – Corrosion on Exterior

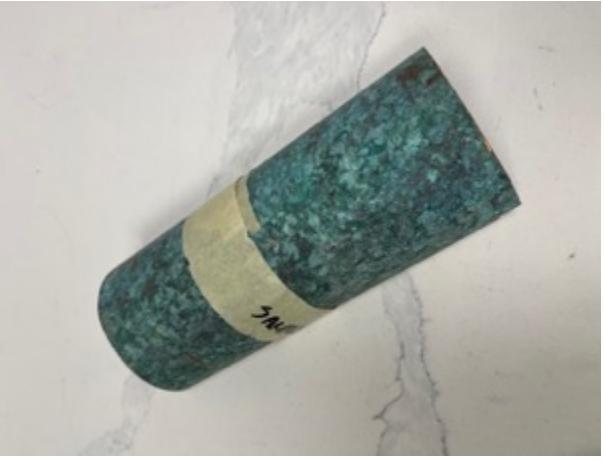
Photo 78. Sample I – Corrosion on Exterior

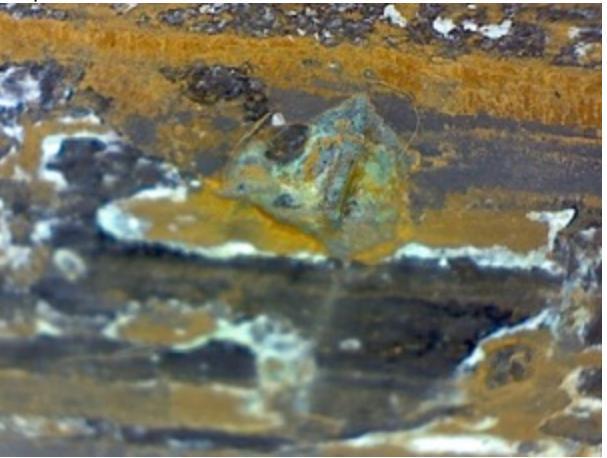
Photo 80. Sample A – Blackened surface with moderate pitting and uniform corrosion

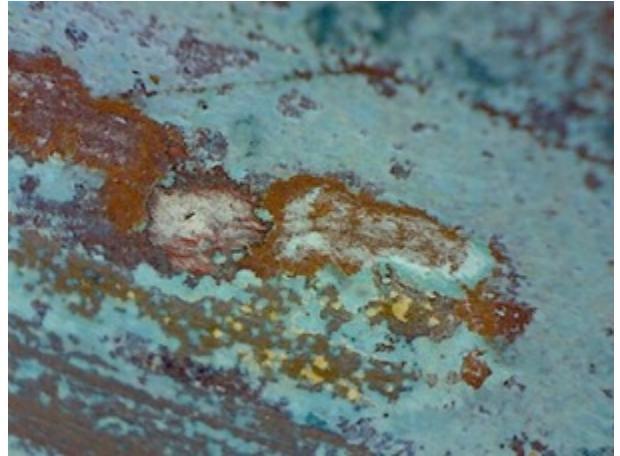
Photo 82. Sample B – Moderate pitting with uniform corrosion

An example of uniform corrosion and cold water pitting is seen in Samples B and F (refer to Photos 81, 82, 89, and 90). Uniform corrosion is a general form of corrosion where the entire surface of the pipe wall is thinning at a uniform rate. Tarnished copper surface and shallow narrow pits characterize uniform corrosion and cold water pitting respectively.

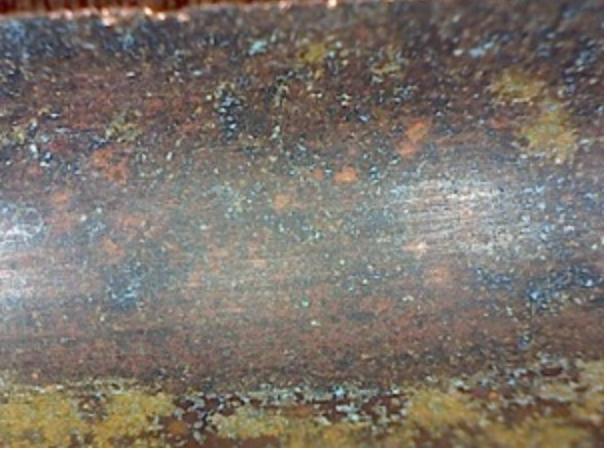
Photo 86. Sample D – Blackened surface with velocity wear and minor pitting

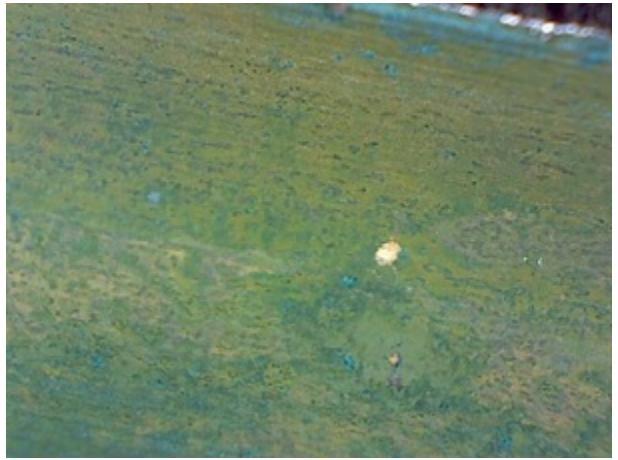
Photo 88. Sample E – Minor pitting with uniform corrosion

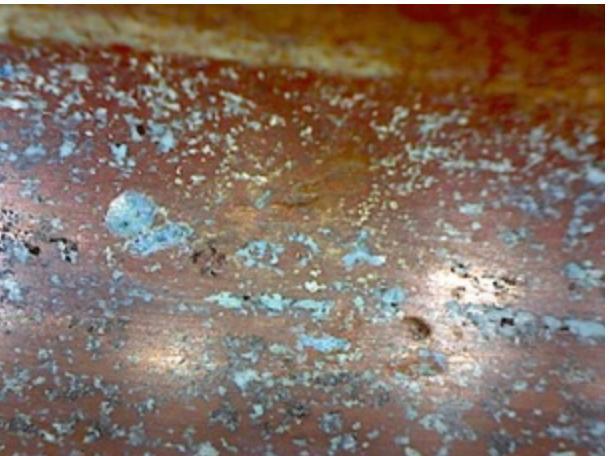
Photo 90. Sample F - Moderate pitting with uniform corrosion

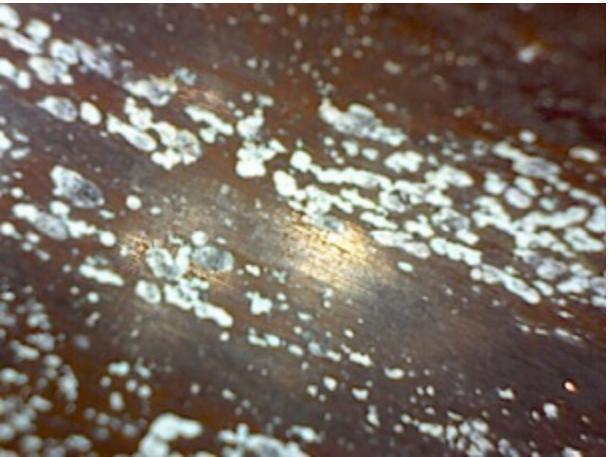
Photo 92. Sample G – Velocity wear and moderate pitting
