To: The Owners, Strata Plan LMS712  
c/o John Boschert, Senior Strata Agent  
FirstService Residential  
700 - 200 Granville Street  
Vancouver BC V6C 1S4

Submitted: December 6, 2024, by  
RDH Building Science Inc.  
4333 Still Creek Drive #400  
Burnaby BC V5C 6S6

**Building Enclosure Condition Assessment Report** | Project 3436.095  
888 Beach, 888 Beach Avenue, 1500 Hornby Street, and 1501 Howe Street, Vancouver, BC

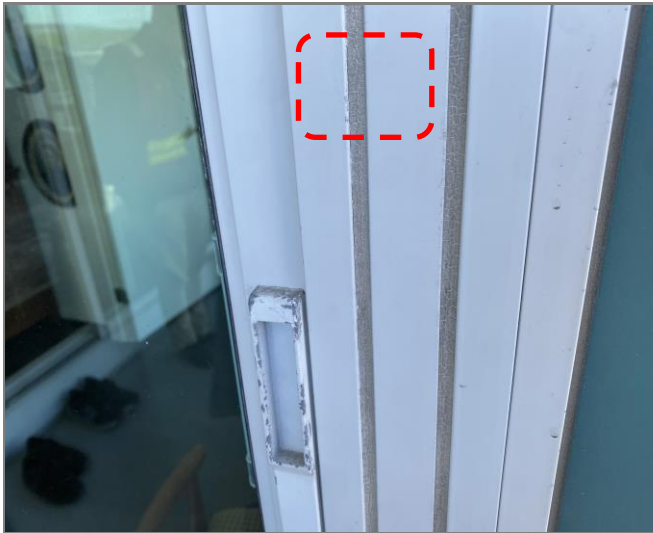
- The window and door perimeter sealant at protected balcony locations are deteriorated and/or reverted (Figure 5.33). Reversion occurs when urethane sealants age and the polymers in the sealant return to their original state (i.e. sticky and flexible). These sealants appear to have been excluded from previous renewals or

maintenance work; however, since they are protected by overhangs, they are less exposed to weathering or potential water ingress.

*Figure 5.33*

*Cracked sealant at protected balcony location.*

*Ocean Tower, Suite 1501, south elevation.*

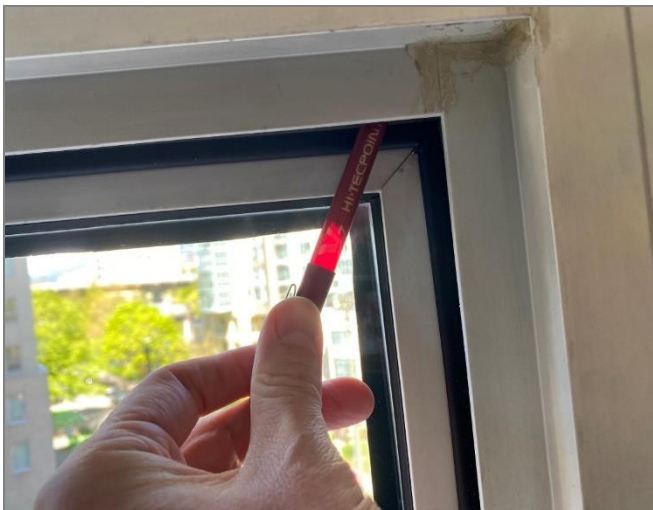
- Several operable awning windows have misaligned hinges resulting in gaps at the top of the windows (Figure 5.34 and Figure 5.35). Some windows have damaged or missing handles (Figure 5.36). Damaged window hinges or handles prevent the windows from closing properly and will result in drafts and heat loss during the winter.

*Figure 5.35*  
Misaligned awning window.  
Beach Tower, Suite 809, west  
elevation.

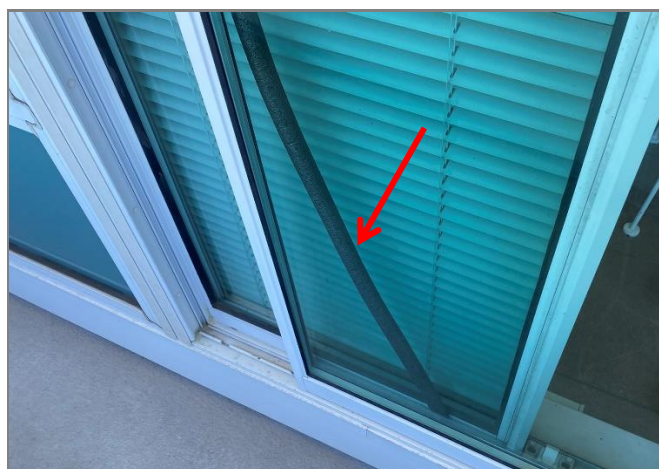
- Some residents have installed supplementary foam gaskets to improve the air tightness and reduce drafts at double-hung sliding glass doors (Figure 5.42).

*Figure 5.42*

*Supplementary foam gasket at double sliding glass door.*

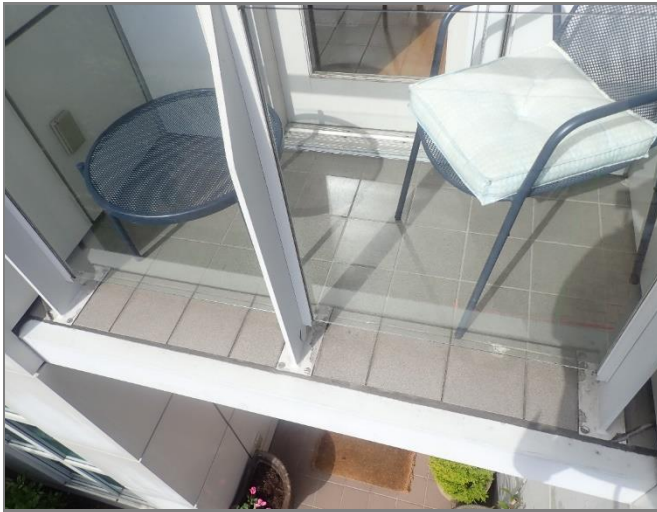
There are original tiled balconies located at the townhouses and the exterior walkway above Beach Avenue. The assembly consists of tile bonded to the cast-in-place concrete balcony. These balcony locations are recessed and include overhangs that provide a greater degree of protection than the typical tower balconies.

*Figure 5.44*

*Typical original tiled balcony  
at Level 2 of Townhouse 14.*

*Ocean Tower, Level 2, south  
elevation*

- The original tiled balcony edges at the townhouses and exterior walkways are stained and the soffit paint is peeling. These locations should be reviewed in further detail to determine the condition of the underlying concrete at balcony edges.

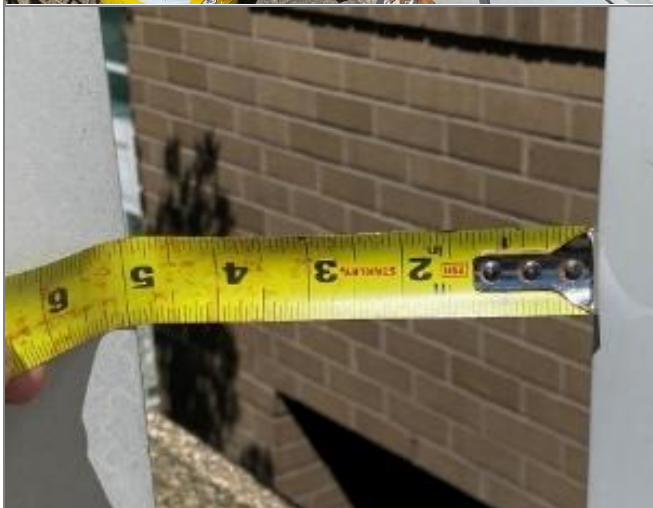
*Guardrail gap at Suite 516.*

*The gap exceeds the allowable size for gaps within guardrails or between guardrails and adjacent structures, per the VBBL requirements.*

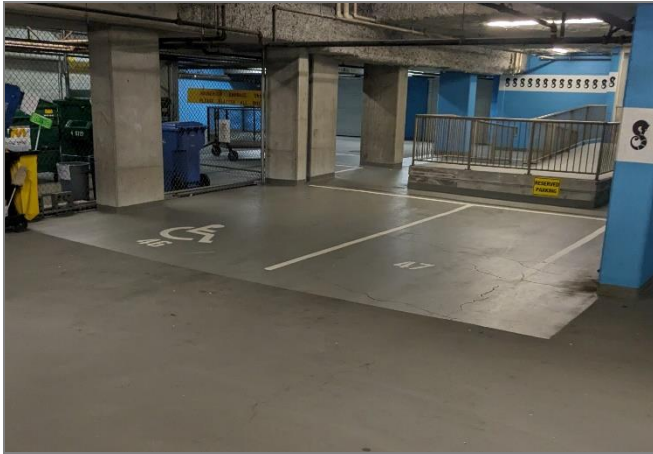
similar to the urethane balcony membranes, although typically with a more robust chemistry and thicker application to withstand vehicle traffic. Localized renewals and repairs of the traffic coating at P1 has been completed in recent years (Figure 5.58).

*Figure 5.58*

*General view of the parkade traffic coating at parkade Level P1.*

- The high-traffic areas of the parkade have increased wear and damage to the traffic bearing membrane. If left unaddressed, the damaged areas will continue to expand and eventually delaminate from the concrete substrate. These areas should be repaired as part of maintenance to prevent further damage.

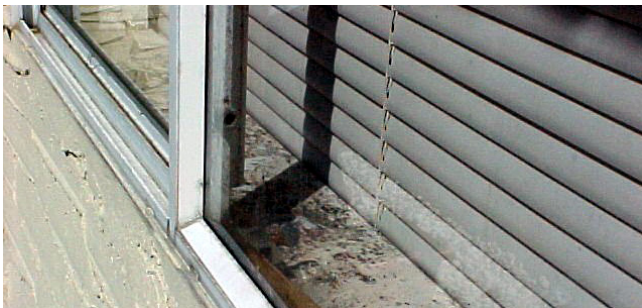
*Evidence of problems resulting from condensation can be seen on the interior window sill.*

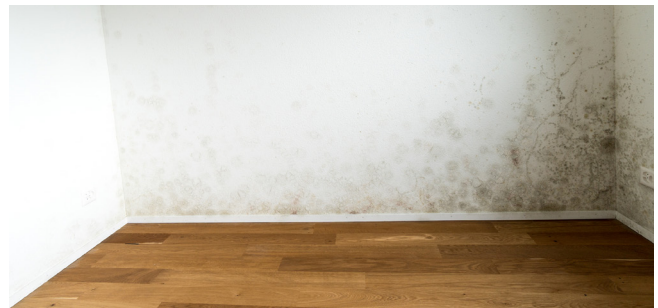
*Condensation has led to mould problems on the drywall.*
