**MINUTES
STRATA COUNCIL MEETING
THE OWNERS STRATA PLAN LMS 712
888 BEACH**

*Held on Tuesday, January 25, 2022
Via Video Conference*

Date: **Jan. 12, 2022**
 Attn: **Strata LMS 712
 c/o Beverly Andrews
 888 Beach Ave
 Vancouver, BC**
 Project: **Tree Transplant Feasibility Study
 888 Beach Ave, Vancouver**
 Re: **Roof Membrane Replacement Project**

ACL File: 21249

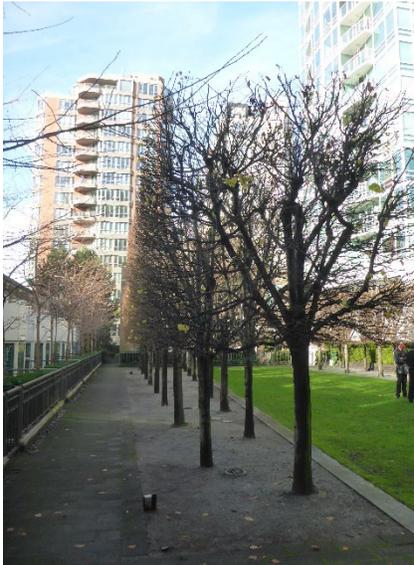
Site Visit Date: Nov 26, 2021 Root Mapping and Soil Property Investigation		
<p>Photo A. West side of the rooftop looking north.</p>	<p>Photo B. Root mapping excavation with rock edge and adjacent soil and grass.</p>	<p>Photo C. Root mapping within adjacent softscape with tree in background</p>

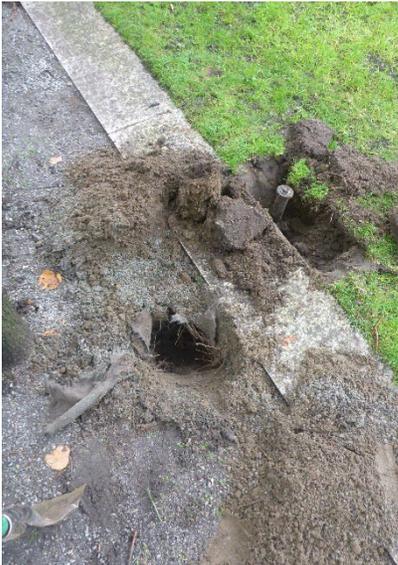
- The trees are growing in a sand base with thick landscape fabric between the sand and compacted gravel that covers the surface area of the tree planter.
- The sand is approximately 75cm deep over the concrete slab.
- The tree planter is constrained by adjacent concrete and wood retaining walls and their footings as well as rock edging set 30cm deep between the trees and the adjacent turfgrass and soil.
- Multiple test pits for root mapping were hand excavated within the sand area beside and between the lindens, as well as into the adjacent turfgrass and soil area beyond the rock edge. Three test pits were hand-dug directly beside the trees to determine the size of the old rootballs (from the nursery) for root mapping as well.

2. Root mapping at the extent of the old rootballs resulted in findings that the old burlap sacs that wrapped the rootballs (from the balled and burlapped nursery preparation) was still intact and the burlap had not disintegrated/biodegraded over time. Roots grew around the old burlap, but not through it. In typical landscape soils, untreated burlap sacs are apt to disintegrate within 1-3 years from the soil biology and chemistry breaking down the fibres. The burlap did not appear to be treated nor did it appear to be synthetic, both conditions that would result in the burlap not being degraded over time by soil chemistry and biology, and weather. The infertility of the sand in the surrounds of the original rootballs was the likely primary contributing factor that the burlap remained intact and substantiates the infertility as it relates to the lack of observed root growth outside of the original rootballs.

In conclusion, the little leaf linden trees growing on the rooftop have not produced sufficient root structures to enable rootballs to be dug for transplanting them. Based on the results of root mapping and soil property analysis, relocating the trees is not feasible. I recommend that to enable the roof membrane to be exposed for replacement, the tree should be removed (cut and disposed of) and replaced with new. I also recommend that the planting site for new trees include appropriate volumes of growing medium (i.e. not sand) as a backfill, and that drainage and watering consider the trees physiological needs. Species choices and spacing should also consider the landscape objectives relative to the maintenance burdens. This office can be requested to extend our consulting services to provide additional support for those aspects upon request.

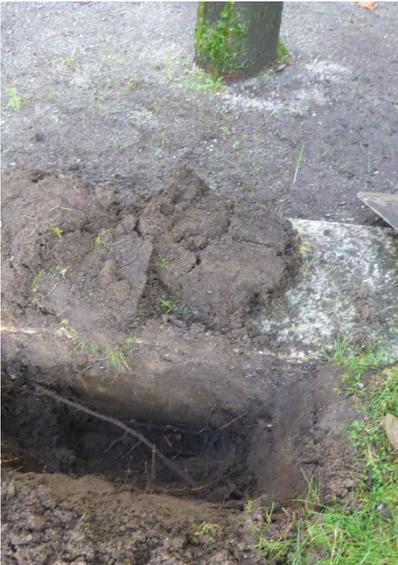
3. The largest woody roots found outside of the original rootballs were 1 to 2 cm \emptyset and were found to be growing from the nearest trees specifically below the rock edge and into the soils where the turfgrass grows. This is an opportunistic root growth strategy whereby the nutrition, water, and oxygen has enabled initial resource collection for the trees, but those roots are not well established at this stage.
