DOMESTIC WATER SYSTEM CONDITION ASSESSMENT

STRATA PLAN LMS 712

Presented to:	Mr. John Boschert FirstService Residential #700 – 200 Granville Street Vancouver, BC. V6C 1S4
Proponent/ Prepared By:	McCuaig & Associates Engineering Ltd. Suite 200 - 3999 Henning Drive Burnaby, BC V5C 6P9
Date :	April 19, 2023
MAE Ref. No.:	20201136-C-RPT-RPT-01-REV1-FNL
	EGBC 1002833

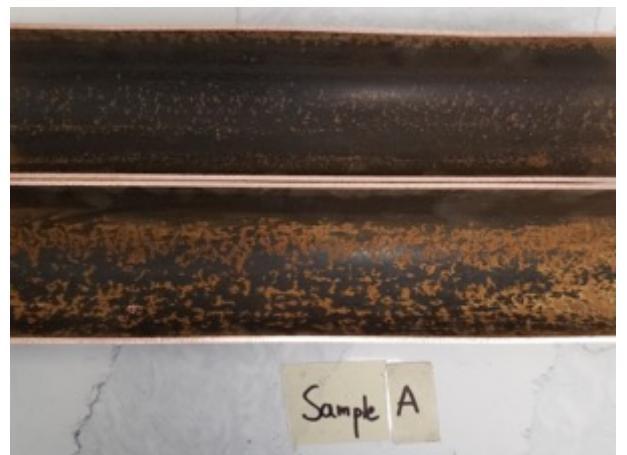
Photo 1. Sample A – P2 Mechanical DHW

Sample	Hot/ Cold	Original Thickness (mm)	Wall Loss (%)	Condition
А	Hot	2.41	2.25	Blackened surface with moderate pitting

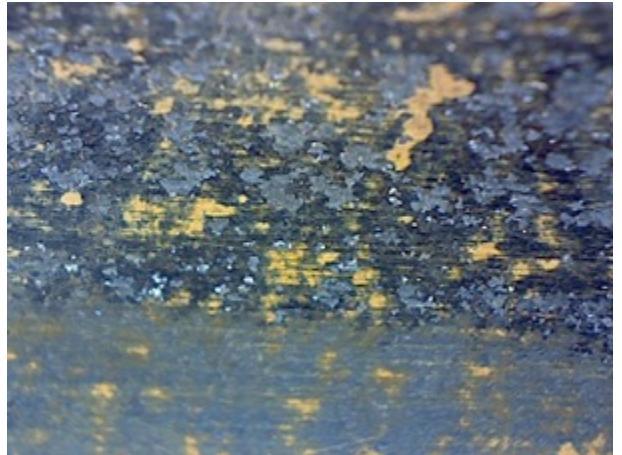
Photo 2. Sample A – Blackened surface with moderate pitting

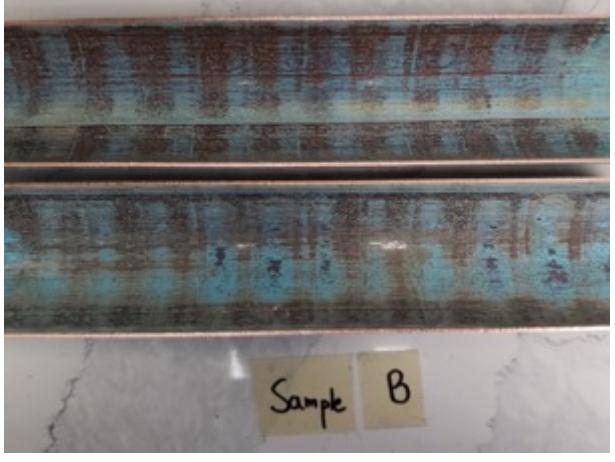
Photo 3. Sample B – P2 Mechanical DCW

An example of uniform corrosion is seen in Sample B, C, E, and F (refer to Photos 3, 4, 5, 6, 9, 10, 11, and 12). Uniform corrosion is a general form of corrosion where the entire surface of the pipe wall is thinning at a uniform rate. Tarnished copper surface and shallow narrow pits characterize uniform corrosion and cold water pitting respectively.

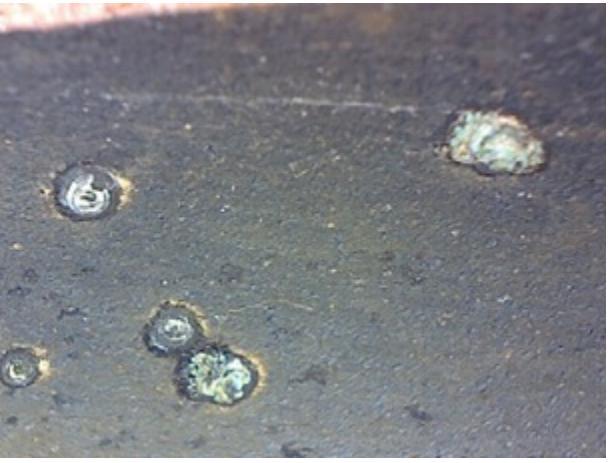
Photo 8. Sample D – Blackened surface with minor pitting

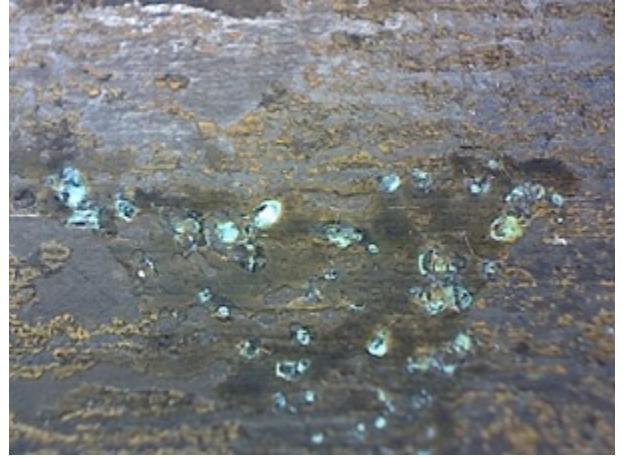
Photo 14. Sample G – Blackened surface with moderate pitting

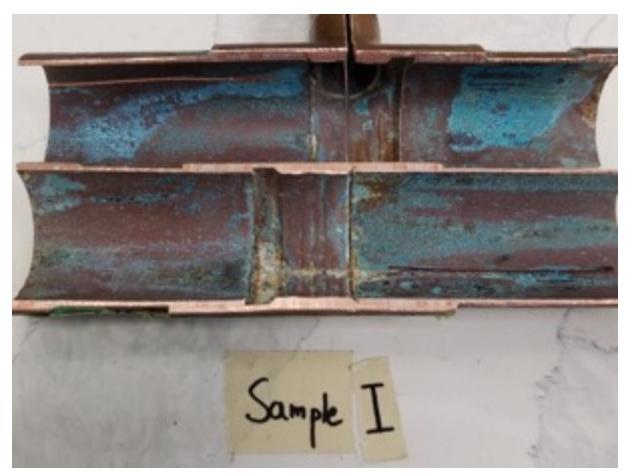
Photo 17. Sample I – Roof Mechanical DCW

Hot water pipes represent typical uniform velocity scouring and hot water pitting. Such deteriorations are characterized by deep pits of small cross sections that are capped by greenish-black mounds and water-swept marks, seen in Sample I and L (refer to Photo 17, 18, 23, and 24). The causes of this kind of corrosion are usually high velocity water and high temperature (over 60 °C).

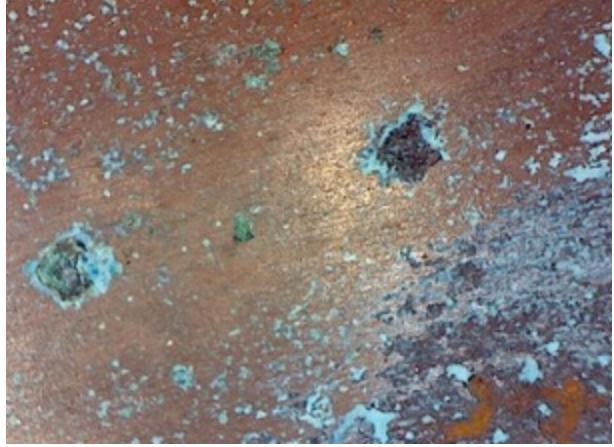
Photo 18. Sample I – Velocity wear and minor pitting

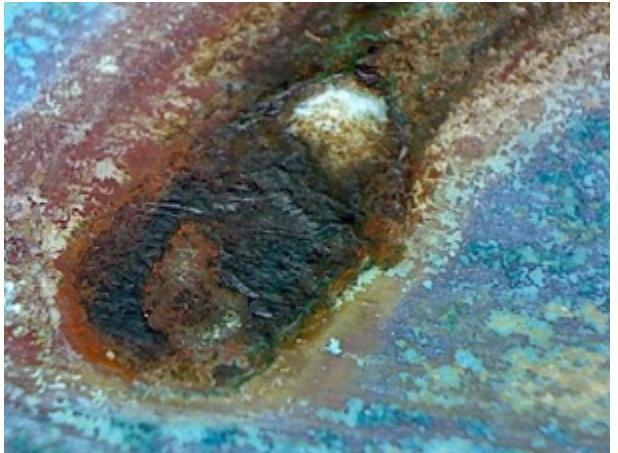
Photo 20. Sample J – Uniform corrosion with moderately severe pitting

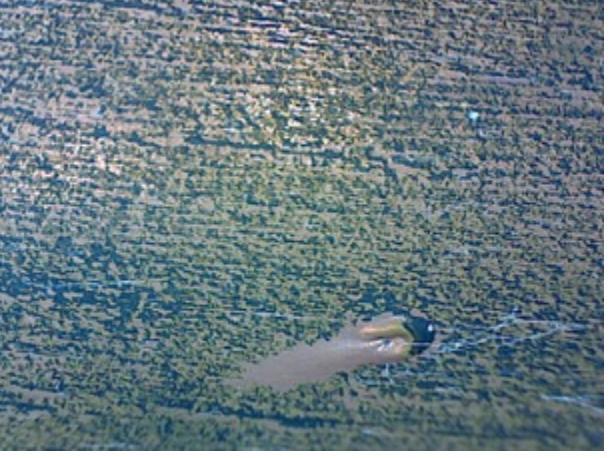
Photo 24. Sample L – Blackened surface with moderate velocity wear and pitting

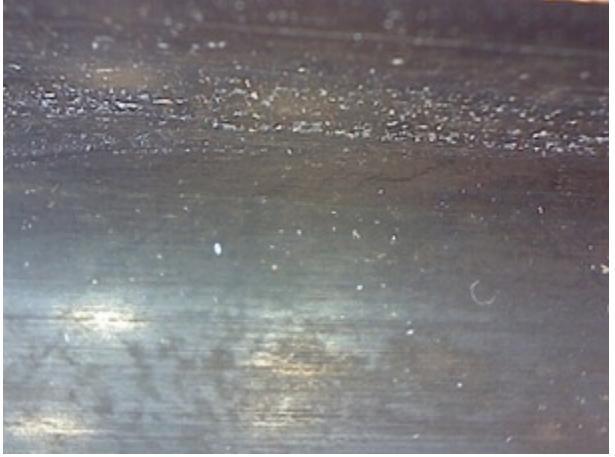
Photo 26. Sample M – Blackened surface with minor pitting

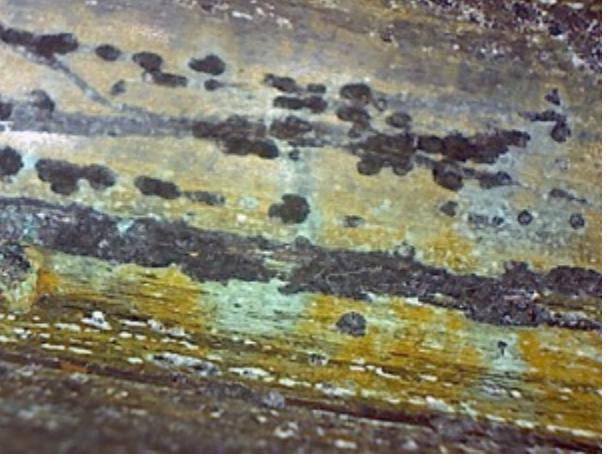
Photo 30. Sample O – Moderate pitting with velocity wear corrosion

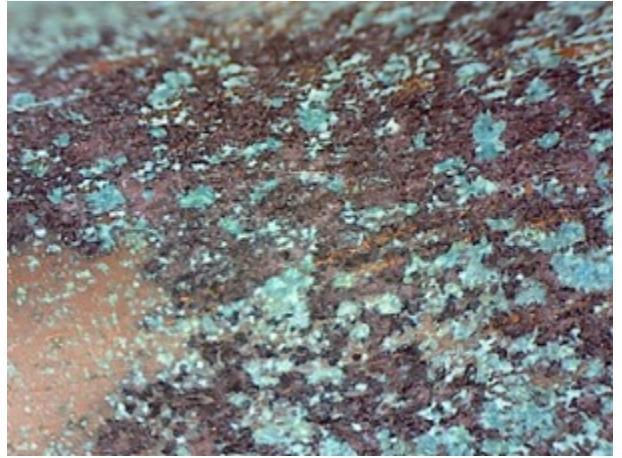
Photo 32. Sample P – Moderate pitting and corrosion

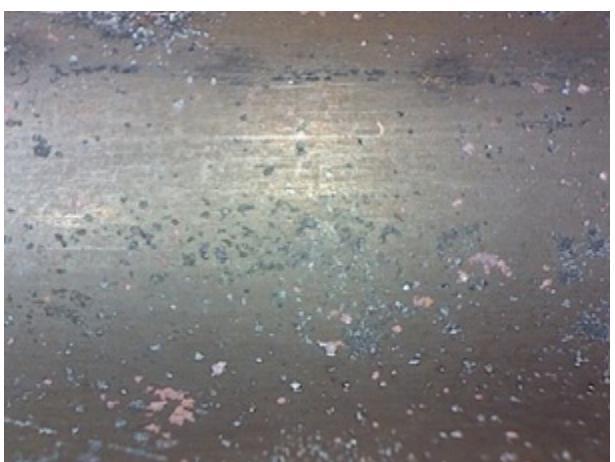
Photo 34. Sample Q – Blackened surface with minor pitting

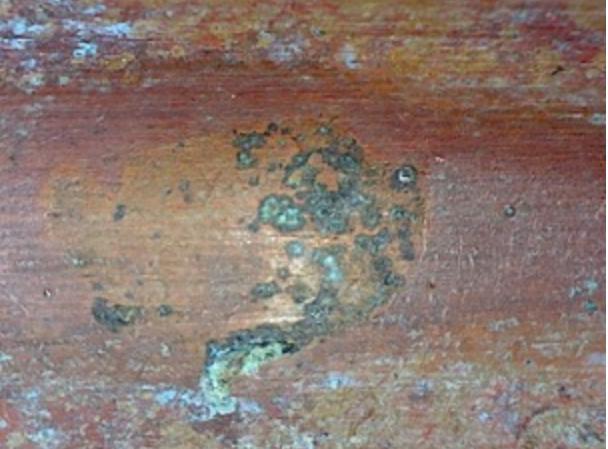
Photo 42. Sample U – Uniform corrosion with minor pitting

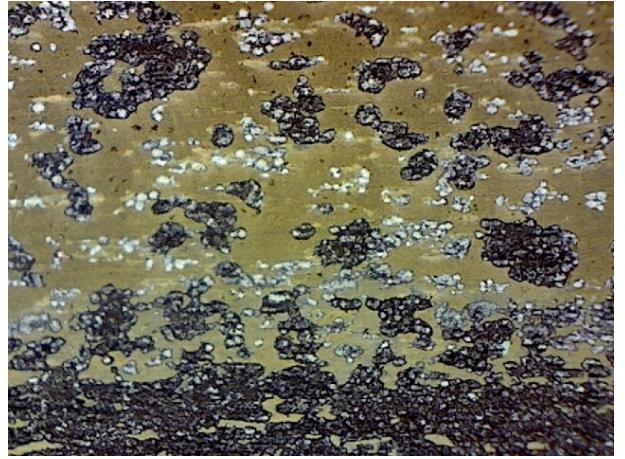
Photo 44. Sample V – Blackened surface with moderate pitting

Manifolds Samples V and W showed moderate pitting on pipe interior (refer to Photo 43, 44, 45, and 46). However, both Samples did not show any signs of pinhole leaks on pipe exterior. Connection of the plastic pipes to manifolds were also observed to be in fair condition without any signs of leaks, and no discoloration was observed.

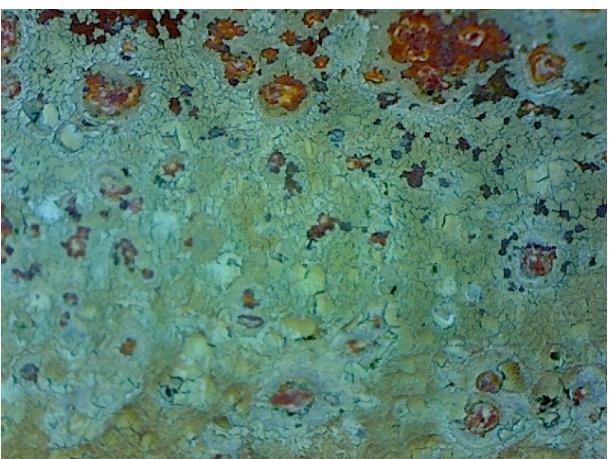
Photo 46. Sample W – Uniform corrosion with moderate pitting

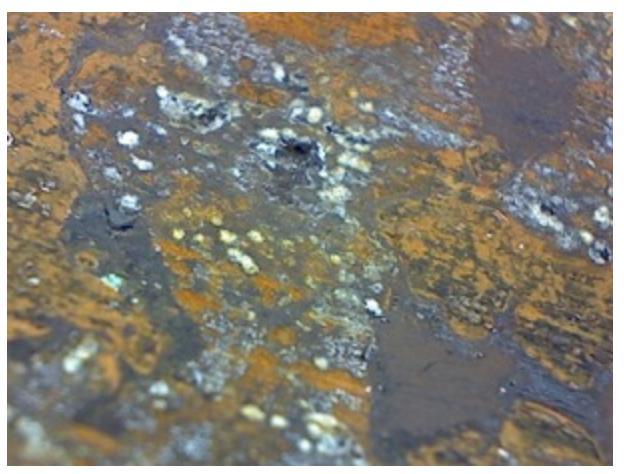
Photo 50. Sample A – Blackened surface with moderate pitting

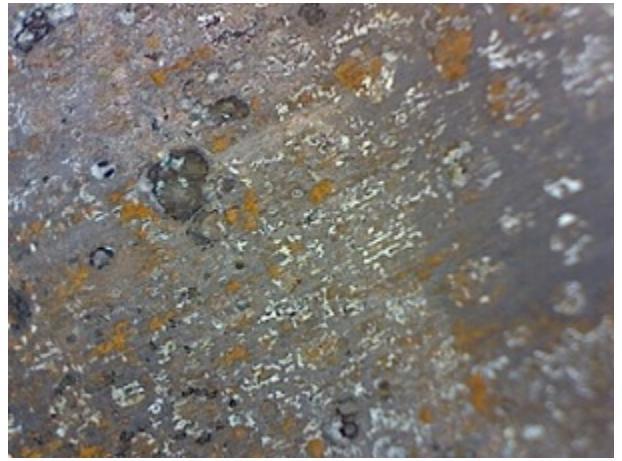
Photo 52. Sample B – Blackened surface with moderate pitting

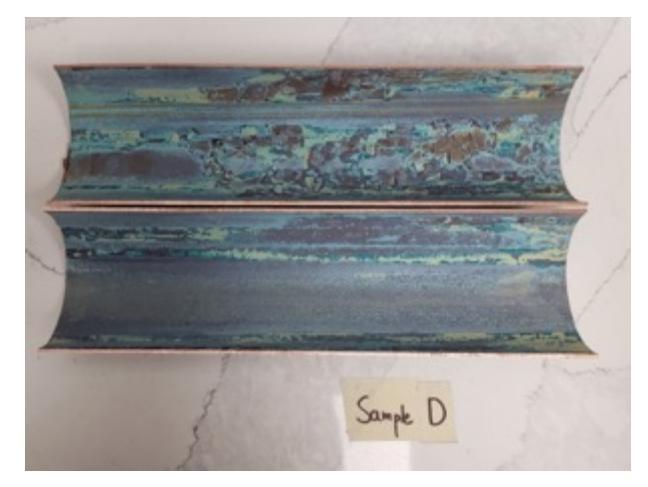
Photo 55. Sample D – P2 Mechanical DCW

An example of uniform corrosion and cold water pitting is seen in Samples D, F, G, and K (refer to Photos 55, 56, 59, 60, 61, 62, 69, and 70). Uniform corrosion is a general form of corrosion where the entire surface of the pipe wall is thinning at a uniform rate. Tarnished copper surface and shallow narrow pits characterize uniform corrosion and cold water pitting respectively.

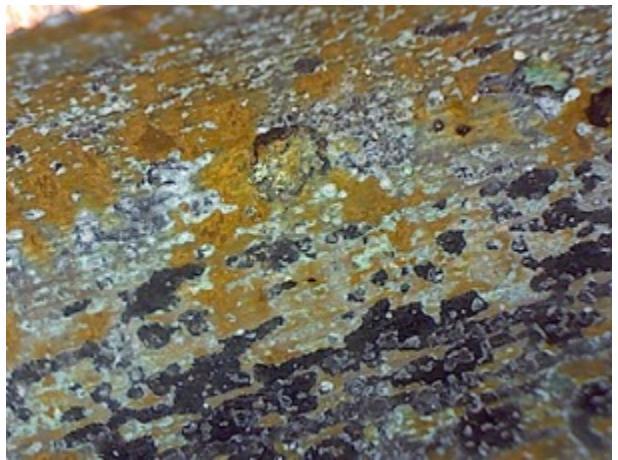
Photo 58. Sample E – Moderately severe pitting

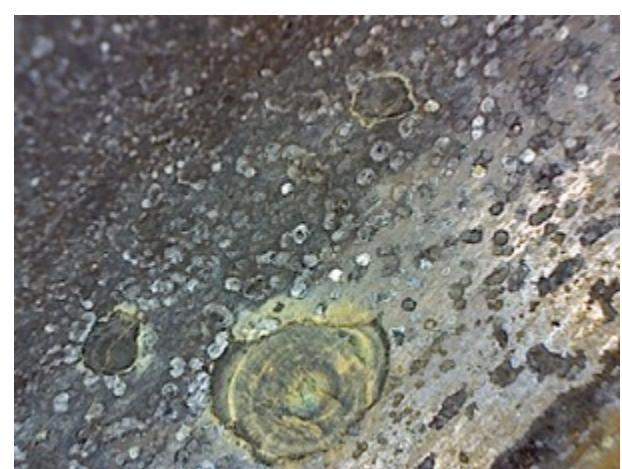
Photo 64. Sample H – Blackened surface with moderate pitting

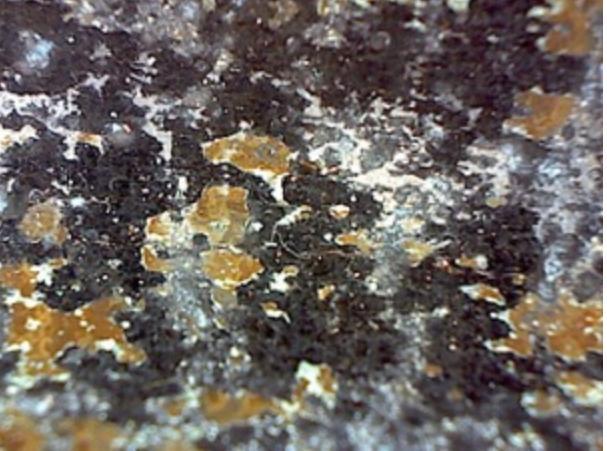
Photo 68. Sample J – Blackened surface with moderately severe pitting

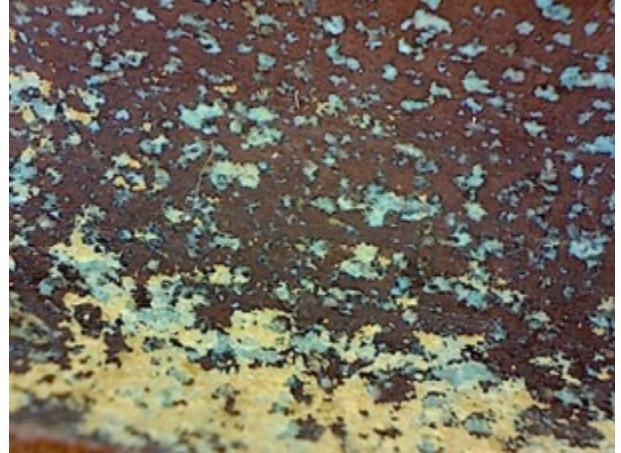
Photo 70. Sample K – Uniform corrosion with moderate pitting

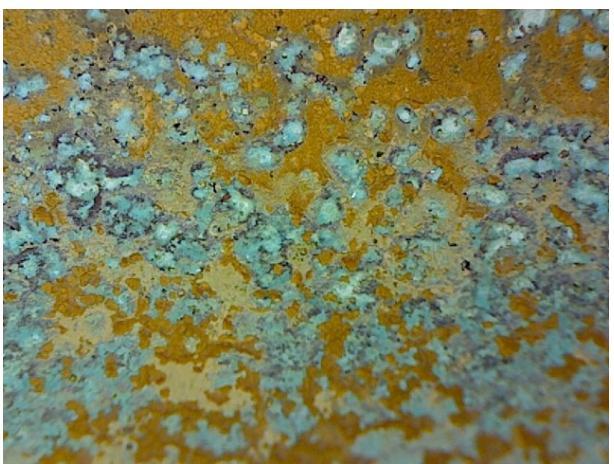
Photo 72. Sample L – Uniform corrosion with moderate pitting

Manifolds Sample L and M both showed uniform corrosion with moderate pitting on the pipe interior (refer to Photos 71, 72, 73, and 74). Sample M did not show any signs of pinhole leaks on the pipe exterior. Connections of the plastic pipes to manifolds were in fair condition without any signs of leaks, and no discoloration was observed. Sample L on the other hand, showed localized corrosion in greenish color on pipe exterior. Also, black discoloration of the pipe exterior was observed, and this may be an indication that the pipe is in contact with other non-compatible metals such as galvanized steel.

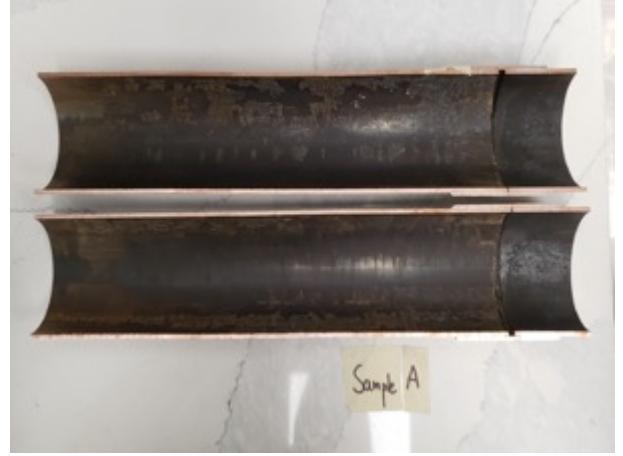
Photo 79. Sample A – Roof Mechanical DHW

Hot water pipes represent typical uniform velocity scouring and hot water pitting. Such deteriorations are characterized by deep pits of small cross sections that are capped by greenish-black mounds and water-swept marks (refer to Photo 79 and 80). The causes of this kind of corrosion are usually high velocity water and high temperature (over 60°C).

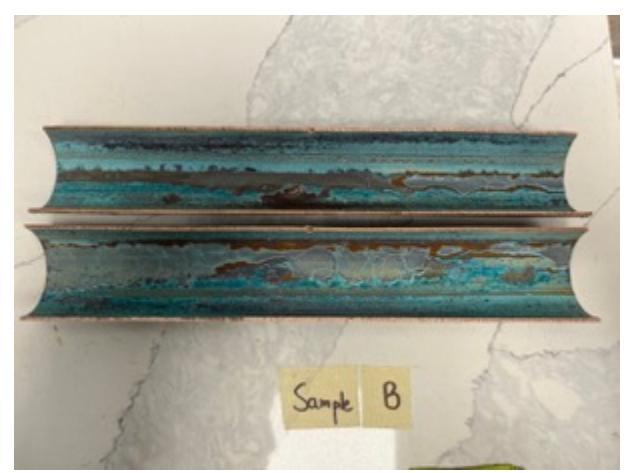
Photo 81. Sample B – Roof Mechanical DCW

An example of uniform corrosion and cold water pitting is seen in Samples B and F (refer to Photos 81, 82, 89, and 90). Uniform corrosion is a general form of corrosion where the entire surface of the pipe wall is thinning at a uniform rate. Tarnished copper surface and shallow narrow pits characterize uniform corrosion and cold water pitting respectively.

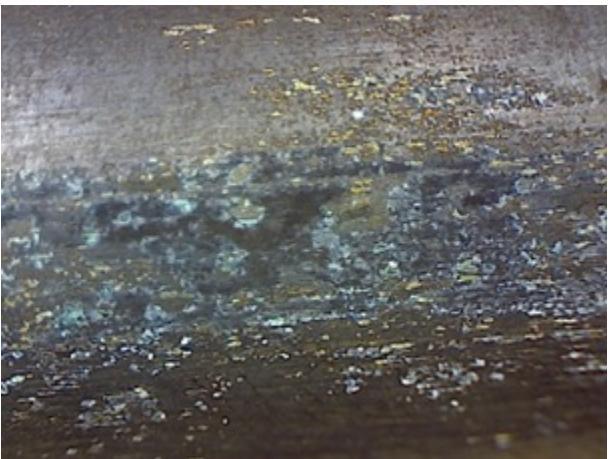
Photo 84. Sample C – Blackened surface with moderate velocity wear

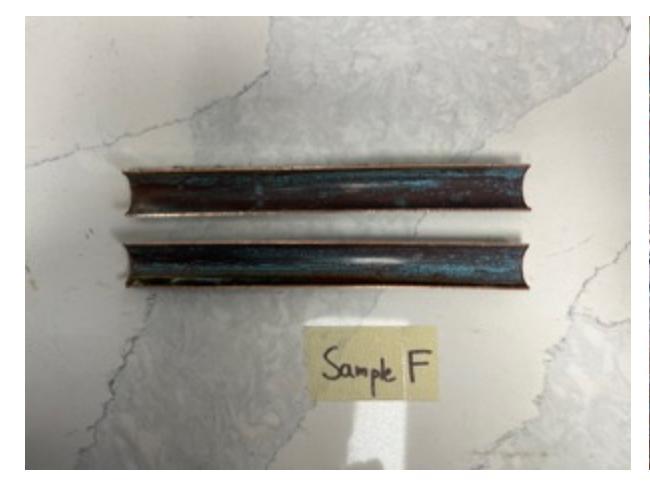
Photo 89. Sample F – TH24 DCW
